**INVESTIGATION OF CRACKS IN FLEXIBLE PAVEMENT ON  
A SECTION OF KAMPALA – MASAKA ROAD**

**A DISSERTATION SUBMITTED TO KYAMBOGO UNIVERSITY DIRECTORATE  
OF RESEARCH AND GRADUATE TRAINING IN PARTIAL FULFILMENT OF  
THE REQUIREMENTS FOR AWARD OF A MASTER OF SCIENCE IN  
CONSTRUCTION TECHNOLOGY AND MANAGEMENT DEGREE OF  
KYAMBOGO UNIVERSITY**

A section of Kampala — Masaka road is facing a distress predominantly cracking experienced on the road. The extensive cracked section of the road is mainly observed from Km 97+000 at Kamuwunga trading centre to Km 102+000 at Lukaya town.

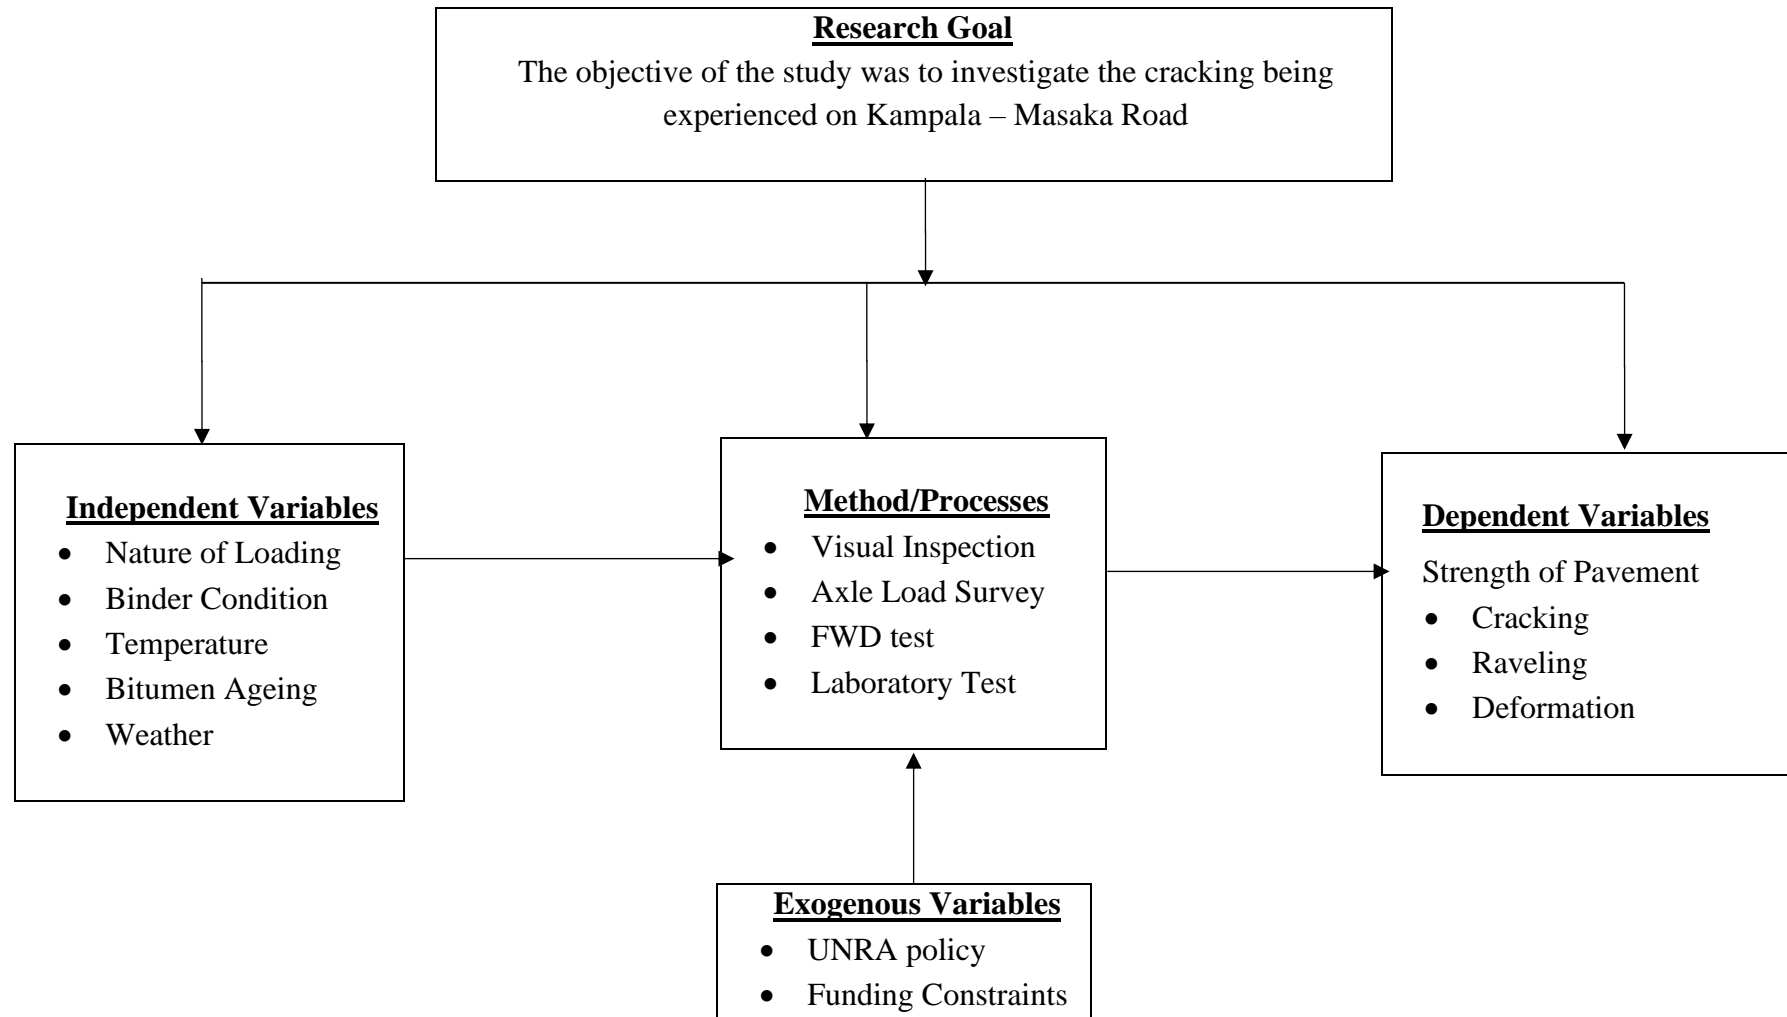
*Figure 1-1: Conceptual framework of the study*

The scheme of concepts or variables were operationalized in the study in order to achieve the set of objectives as shown diagrammatically in Figure 1.1. This entails the ultimate goal (research focus), independent variables, dependent variables, analysis methods and ultimate outcome.

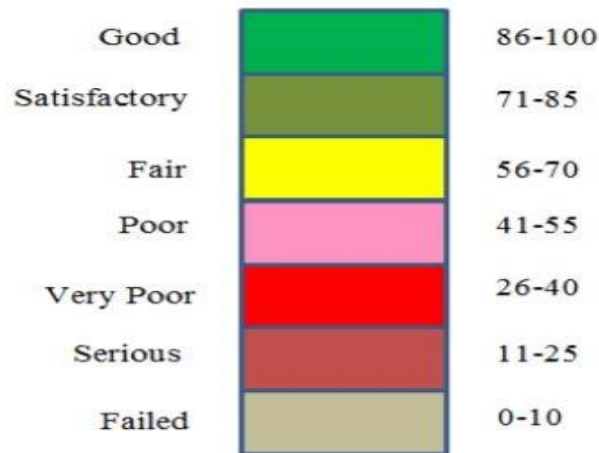
*Figure 2-7 Pavement condition index, rating scale and suggested colors*

The US Army Corps of Engineers created the PCI measured condition rating system, which was subsequently embraced by the American Public Works Association and the American Society for Testing and Materials (ASTM) (ASTM D6433-11, 2011). It is based on a 0-100 scale, as illustrated in Figure 2.7. (Illinois Center for Transportation, research Report). Based on the kind, intensity, and extent of each distress found on the pavement, a value is assigned to it. The rating of the pavement condition is then determined by adding all the points and subtracting them from a total of 100. Condition of the entire section as determined by the weighted average of the PCIs for multiple sub-layers of pavements and 19 distress kinds for flexible pavements. There are 39

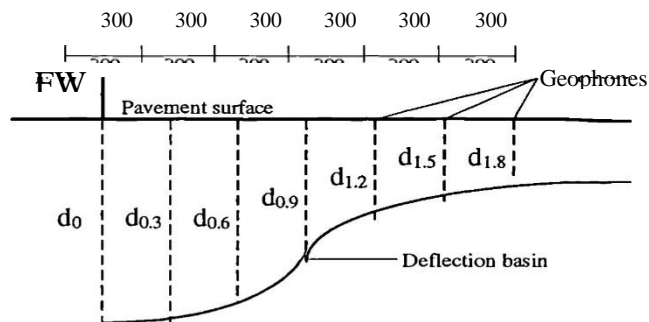
**Figure 2-8: Configuration of the FWD**

- ii. Short test duration and rapid data collection;
- iii. Simple testing procedures;
- iv. No physical damage to the pavement structure;
- v. No disturbance effect to the sample;
- vi. It can simulate the effect of moving traffic loads; and
- vii. Full scale model test where the test measures the insitu pavement behaviour under traffic load.

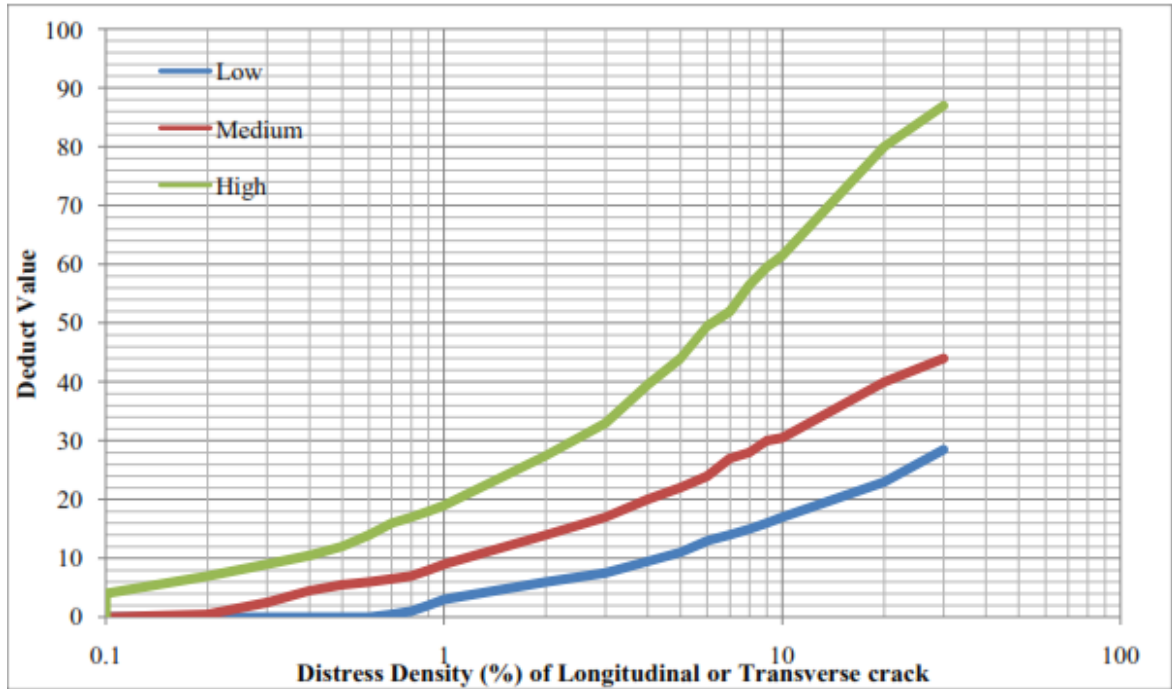
*Figure 3-1: Typical deduct value curves for Longitudinal or Transverse crack*

Figure 3.1 shows typical deduct value curve for longitudinal cracking.

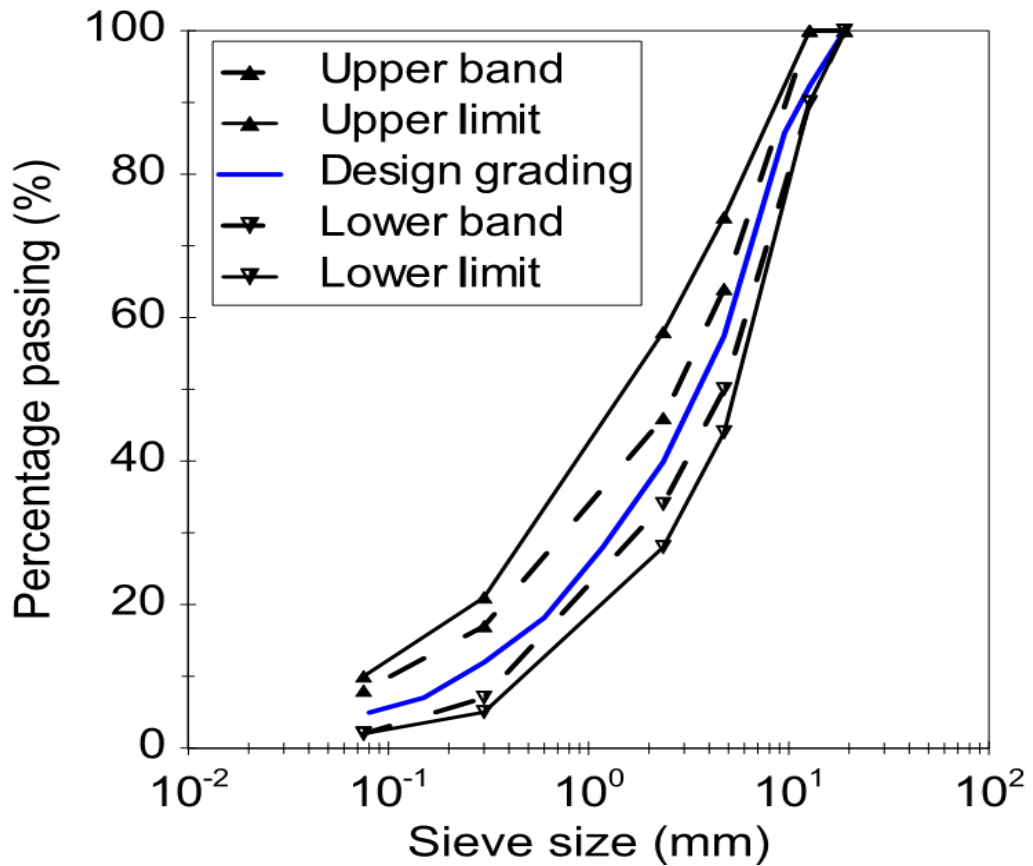
*Figure 3-3: Aggregate grading curves and mix design band*

The ignition method was used to obtain the aggregates from the AC cores, this procedure removes the surface areas (containing cut aggregate) from each core. The material is then combined, split, asphalt cement is removed in the ignition oven, and finally gradation is determined. The aggregate grading curves, constructed according to specifications (MoWT, 2005) are depicted in Figure 3.3. The sieves' opening range related with sieve percentage passing is indicated, as well as the working formula and mix design grading, considering a 1/2 in (12.5 mm) maximum aggregate size. The working formula is obtained from the design curve plus/minus the tolerance values that depend on sieve size.

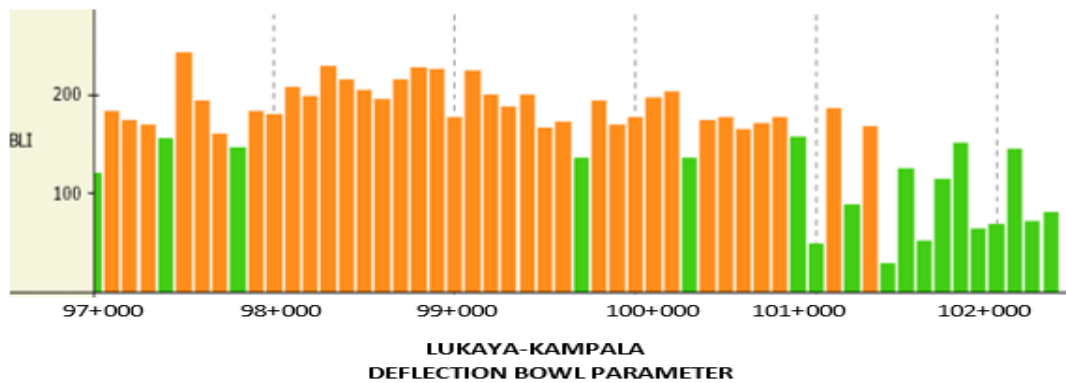
*Figure 4-4: Base Layer Index benchmarking for Km 97+000 to Km 102+000*

The Base/Top Layer Index (BLI) benchmarking shown in Figure 4.4 shows that Km 101+000 to Km 102+000 represented by green colour indicates that the structural condition is sound with the deflection bowl parameters being greater than 200mm. The remaining section of the study road is represented by amber colour indicating that the structural condition is warning with the deflection bowl parameters ranging from 200mm to 400mm.

These indicate that the base layer is increasingly drifting into the warning condition over large sections of pass. The surveyed visual condition rating over this section was mostly warning owing to cracks permitting the ingress of large quantities of water which soak the base thereby compromising its structural integrity. The distress thus observed therefore possibly originate largely from the asphalt and the base layer and, to a lesser extent, from the sub-base/subgrade.

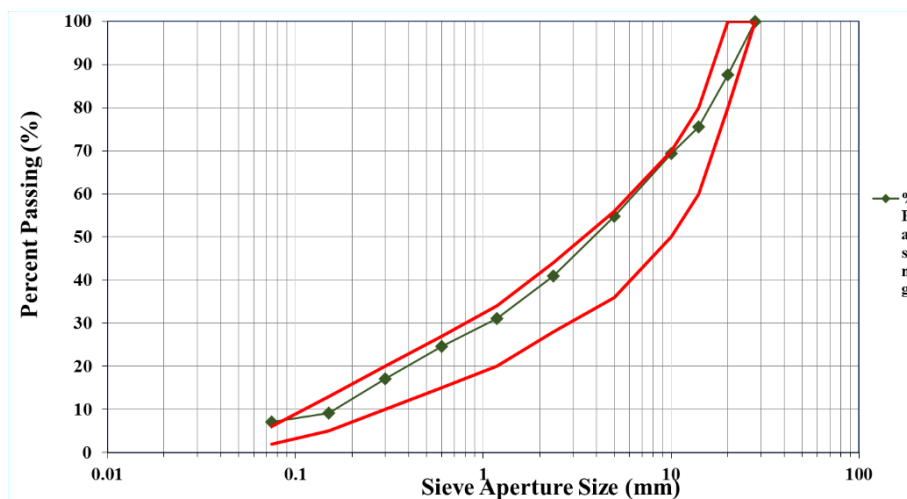
**Figure 4-5: Gradation curve for the aggregate from the extracted cores**

One of the most relevant factors in performance-based design of asphalt mixtures is the gradation of the aggregates. The role of aggregates in the performance and durability of an asphalt mixture is critical (Lambebo, 2020). Knowledge of particle size distribution is necessary to determine the grading of materials proposed for use in road pavement. Therefore, its result gives the percentages of different aggregate fractions present in the aggregate sample. Accordingly, the particle size distribution of the aggregate sample as compared with national specifications (MoWT, 2005) are shown in Figure 4.5.

As it can be seen from Figure 4.5, the coarse aggregate meets the requirements for the particle size distribution for use as wearing course material in roads. The shape of aggregates were observed to be angular, therefore the cracks observed on the surface are not as a result of the particle size distribution, hence aggregates were not part of the cause of cracking.

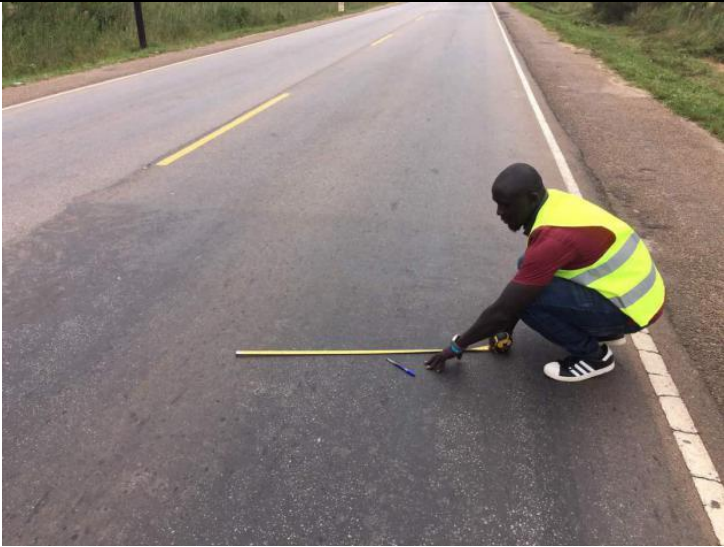
<p>Bleeding of bitumen from Km 97+200 to Km 97+590 –</p>

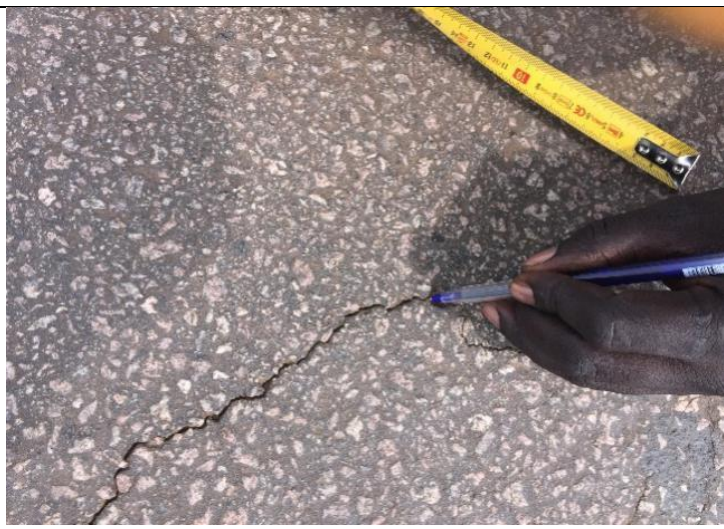
<p>Alligator cracks with wider width &gt;3mm from Km 98+180 to Km 98+270 –</p>

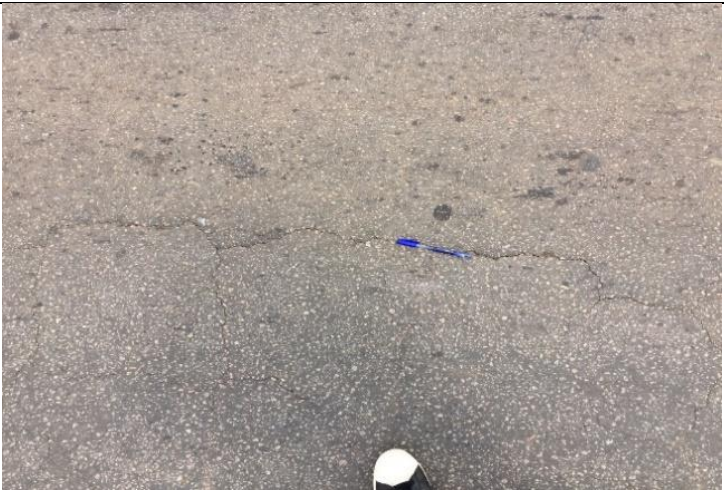
<p>Longitudinal cracks developing from series of alligator cracks from Km 98+150 to Km 98+280 –</p>

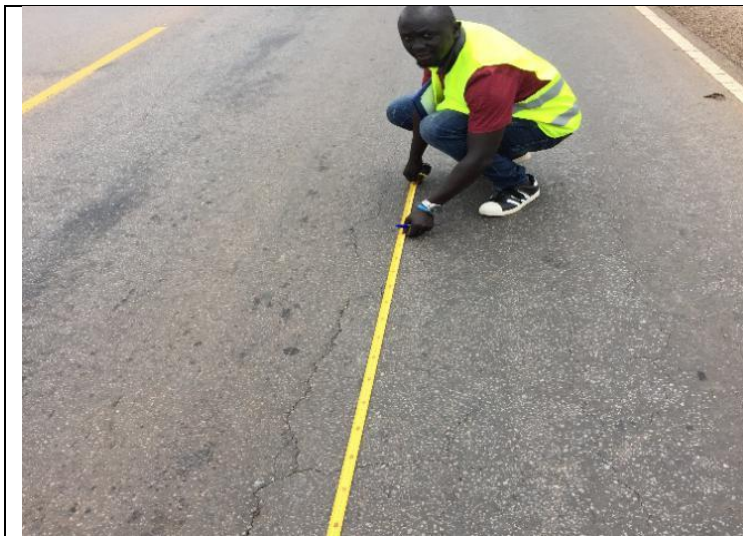
Measuring the length of longitudinal cracks from Km 98+640 to Km 98+890 –

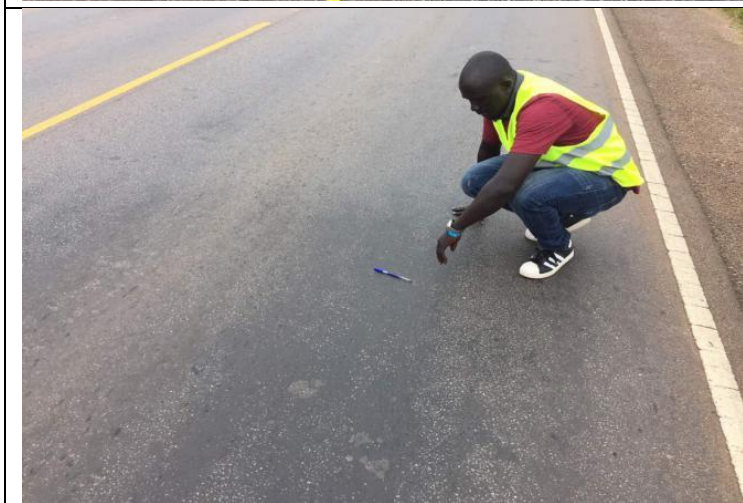
Aggregate loss from bitumen from Km 99+710 to Km 99+870 –

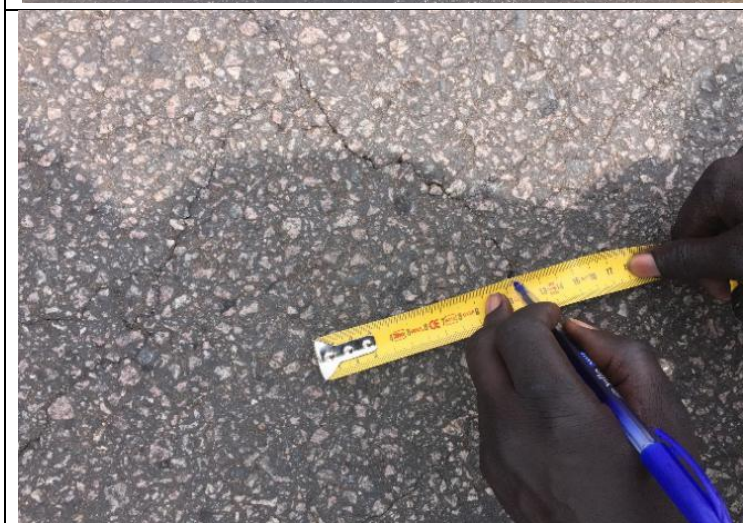
Measuring the width and depth of Alligator cracks at Km 101+330 and Km 101+490

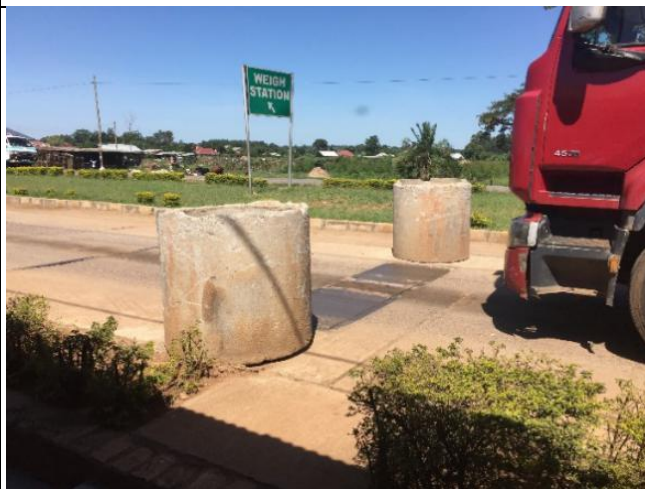
Axle Load survey at weigh bridge in Lukaya

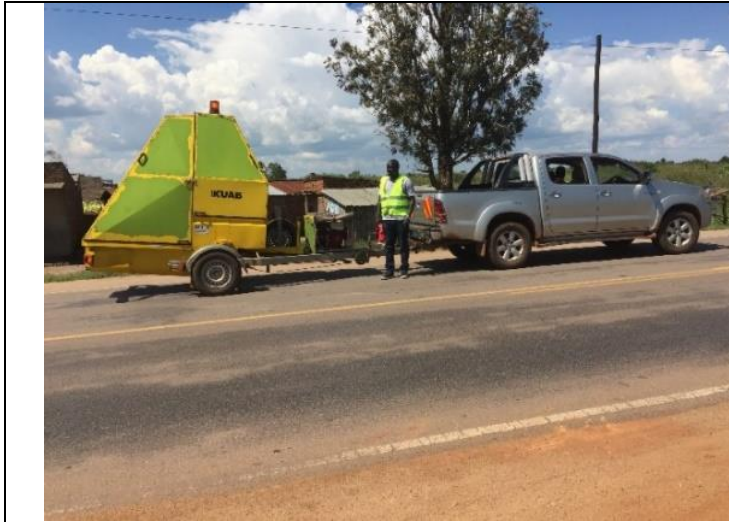
FWD testing at Km 97+700

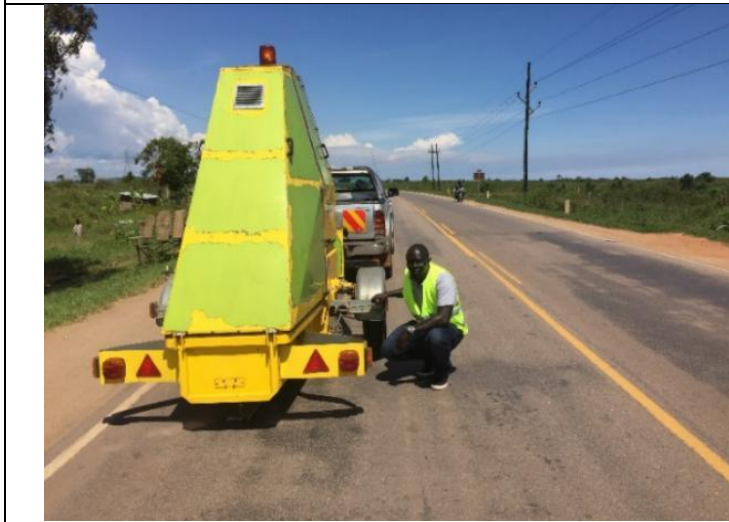
FWD testing at Km 98+210

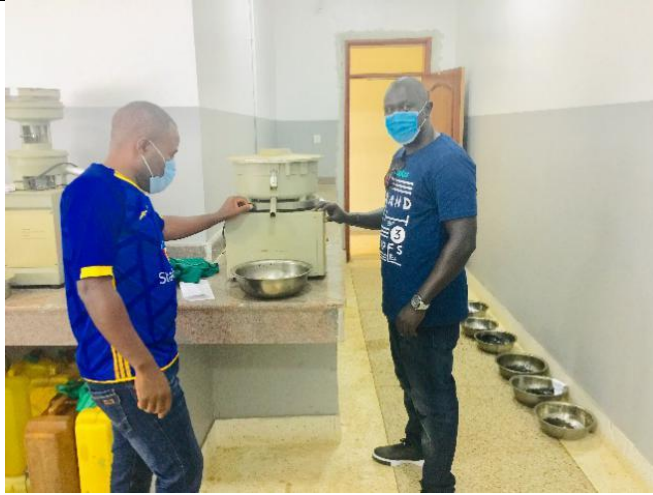
Extraction of cores to separate bitumen from aggregates

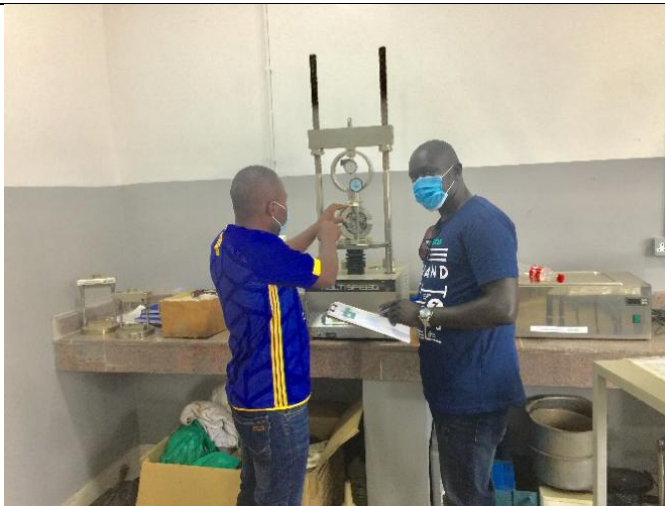
Lab test on cores for ITS test
