**DEPARTMENT OF MECHANICAL AND PRODUCTION ENGINEERING**

**PERFORMANCE ANALYSIS OF THE TOP ROLLERS IN A SUGAR  
MILL USING FINITE ELEMENT METHOD**

A Dissertation submitted to the Graduate School in fulfilment of the Requirements for the  
Award of the degree of Master of Science in Advanced Manufacturing Systems Engineering  
of Kyambogo University

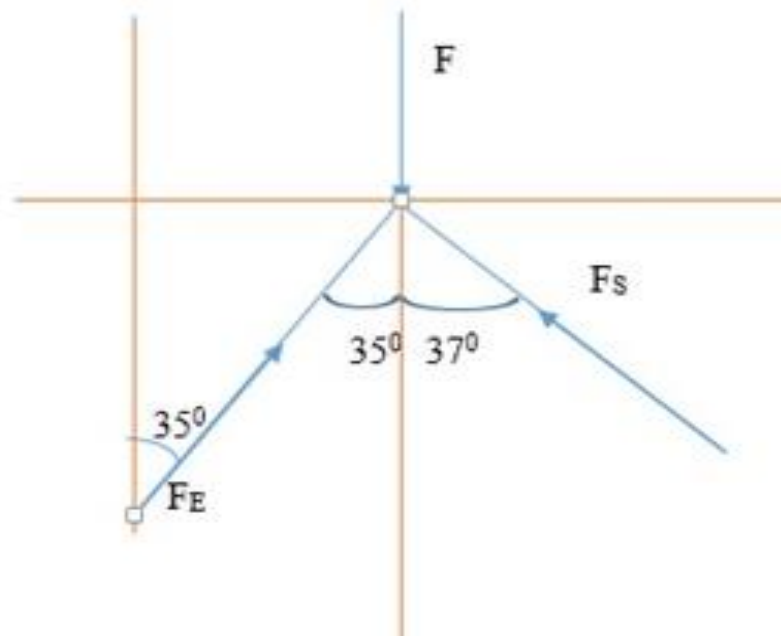
Figure 3.1: Crushing forces on top roller shell for mill 1 through 4

$\sum V_C$  – Sum of the horizontal crushing forces due to hydraulic pressure.

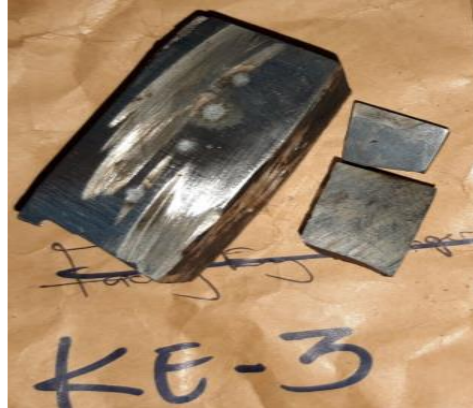
Specimens were cut from the broken top roller component material and ground to the required size for tests. The failed part of the top roller and box coupling was cut off using oxy-acetylene cutting and immediately preserved under the oil for 8 days before the tests to allow it cool and inhibit any alteration in the material structural properties. Figures 3.3, 3.4, 3.5 and 3.6 are the samples of specimens that were cut for tests.

*Figure 3.3: Specimen 1 cut from a failed top roller shaft KE-3 in 4th mill*

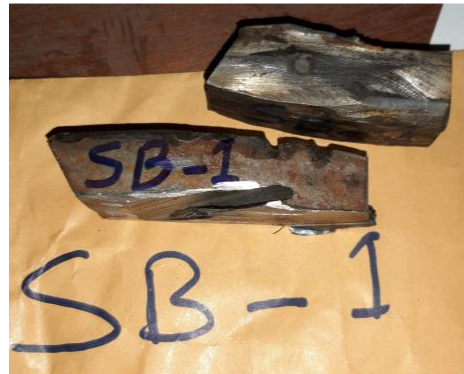
*Figure 3.4: Specimen 2 cut from broken top roller SB-1 in 3rd mill*

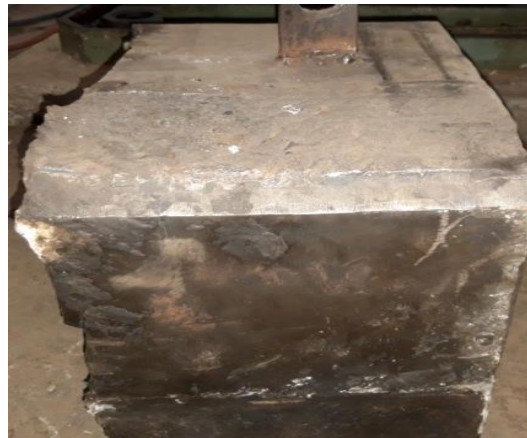
*Figure 3.5: Specimen 3 cut from the broken square end for top roller shaft KE-8 in 4th Mill*

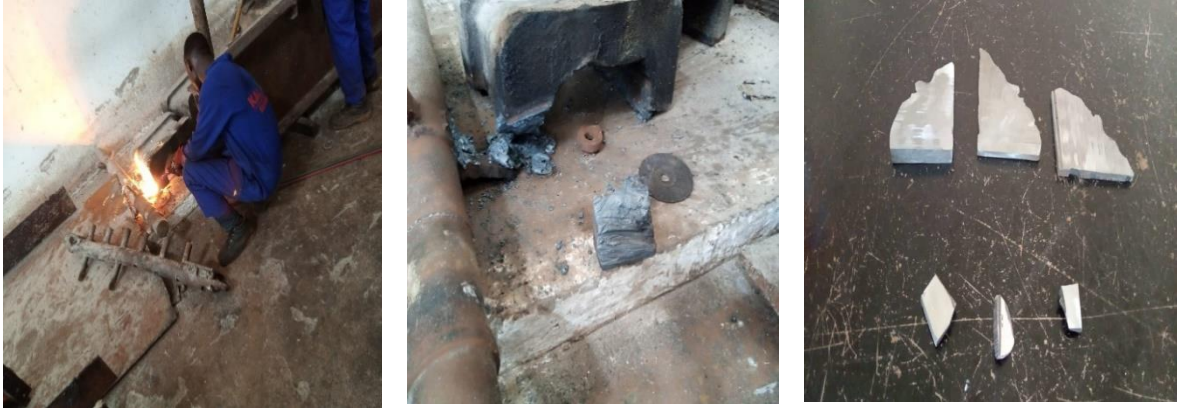
Figure 3.6: Specimen 4 cut from a worn box coupling for the top roller mill 4

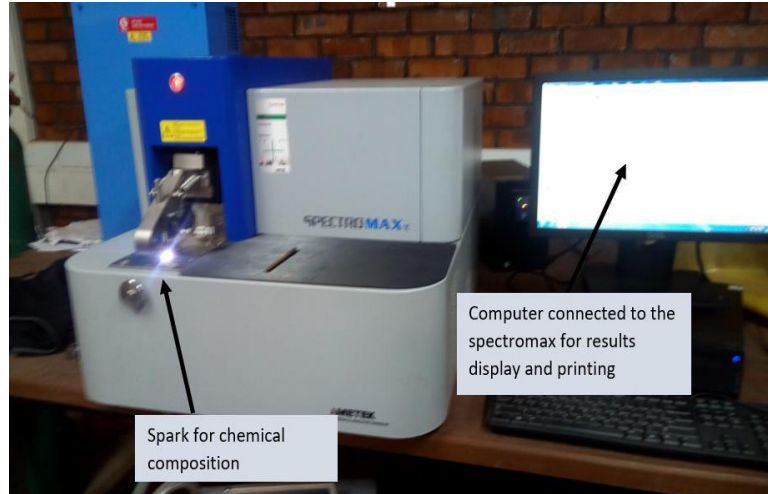
A Spark Emission Spectrometer SPECTROLAB in figure 3.8 for AMi1 and Thermo Scientific ARL OES Spectrometer for BMi2, Test pieces of 20mm were cut from the main shaft, polished and placed at the test position of SPECTROLAB/ Thermo Scientific ARL OES Spectrometer made in UK and a spark is directed towards the surface of the test piece. A printout from the computer attached to the microscope was printed out for chemical composition analysis.

*Figure 3.8: Computerized Spark Arc Spectrometer*

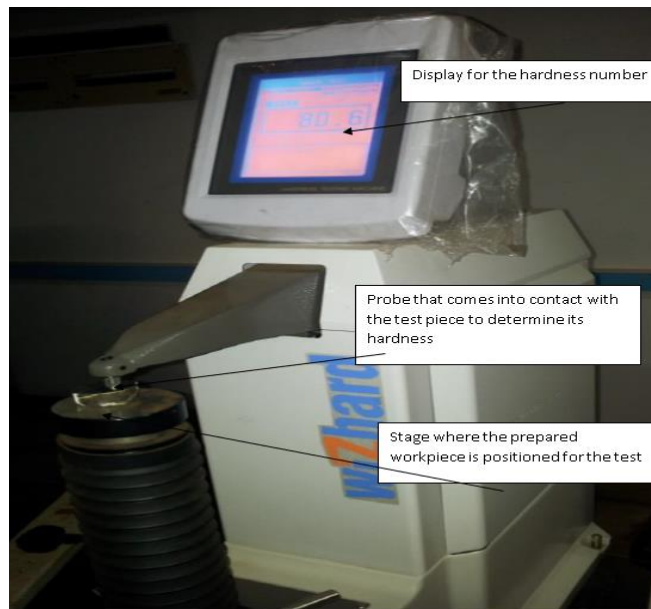
Test pieces were cut from the parent metal and machined to the required diameter of length 20mm and mounted on the Rockwell hard testing machine (WIZHARD) to determine the HRC number of the test piece. HRC number was used for the analysis of the performance of the shaft under fatigue loading. Figure 3.9 is the HRC machine used during the experiment.

*Figure 3.9: Mutitoyo Digital Hardness Testing Machine*

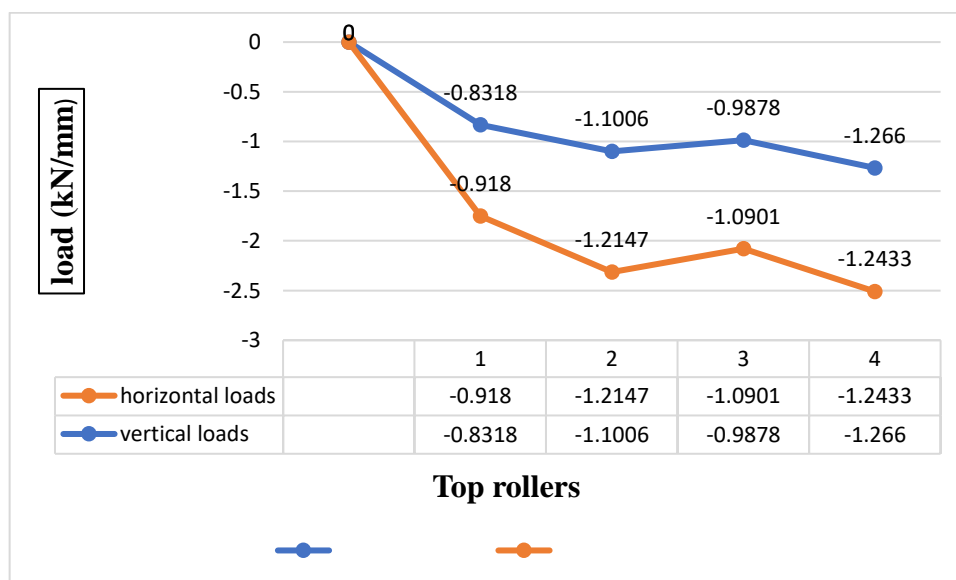
The sugarcane Bagasse was crushed with the help of a hydraulic piston with about 20% of the pressure loss to the trash plate, 80% for crushing the bagasse at the discharge opening and delivery opening (Hugot, 2014). Force, F, exerted by hydraulic loading on top roller was calculated using Equation 3.1 and the values of the forces exerted on each of the four top rollers are given in appendix 1(a).

*Figure 4.1: Forces on the crushing length of the top rollers*

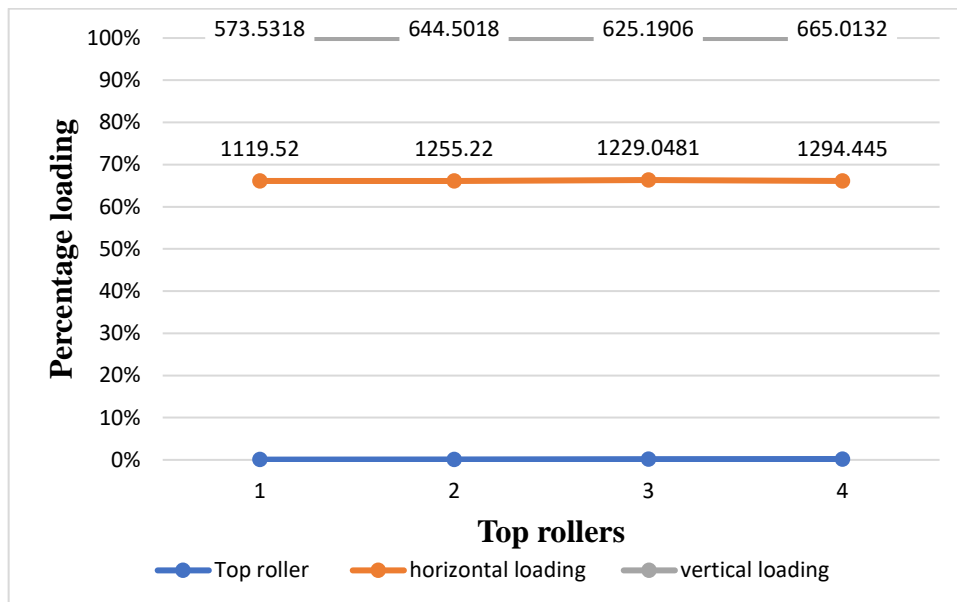
The forces at the pinion are obtained using Equation 3.12, 3.13, 3.14, 3.15, 3.16 and 3.17 and the forces on the pinions for rollers 1, 2, 3, and 4.

Figure 4.2: Forces on the pinion

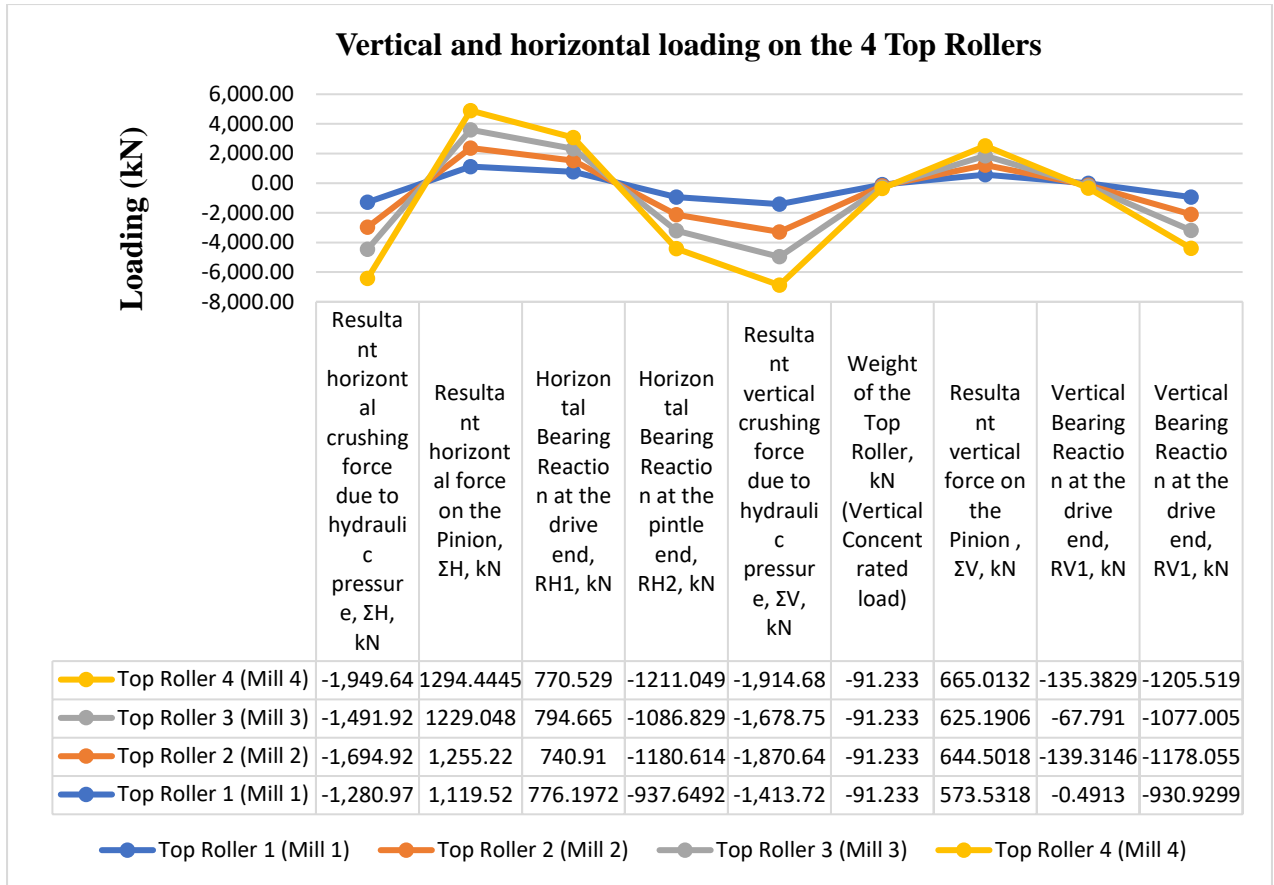
The summary of vertical and horizontal loading on the Top Rollers 1 through 4 at the pinion, bearing, weight of the Top Roller and Shell, and at the crushing length are shown in the appendix 1(f).

*Figure 4.4: Horizontal and vertical loading on the Top Roller 1 through 4*

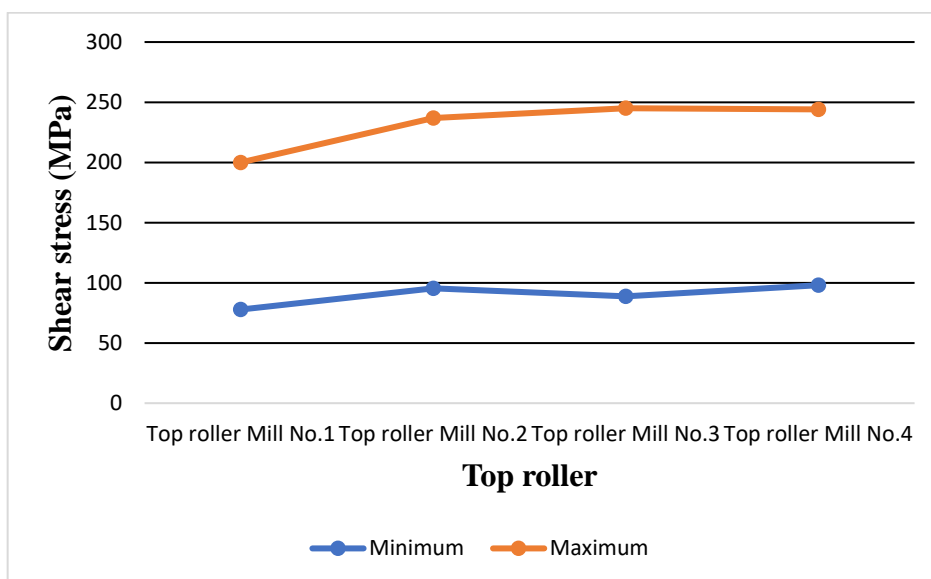
Minimum and Maximum values of stresses on the top rollers					
Variable	Observations	Obs. with missing data	Obs. without missing data	Minimum	Maximum
Top roller Mill No.1	4	0	4	77.800	200.000
Top roller Mill No.2	4	0	4	95.500	237.000
Top roller Mill No.3	4	0	4	88.850	245.000
Top roller Mill No.4	4	0	4	98.000	244.000
<b>Summary statistics of loading on different shaft sections:</b>					
Variable	Observations	Obs. with missing data	Obs. without missing data	Minimum	Maximum
Maximum bending moment point	4	0	4	77.800	98.000
Shoulder A	4	0	4	97.100	112.300
Shoulder B	4	0	4	200.000	245.000
Keyway	4	0	4	191.500	207.750

Figure 4.5: Minimum and maximum shear stress on different Top roller Mills

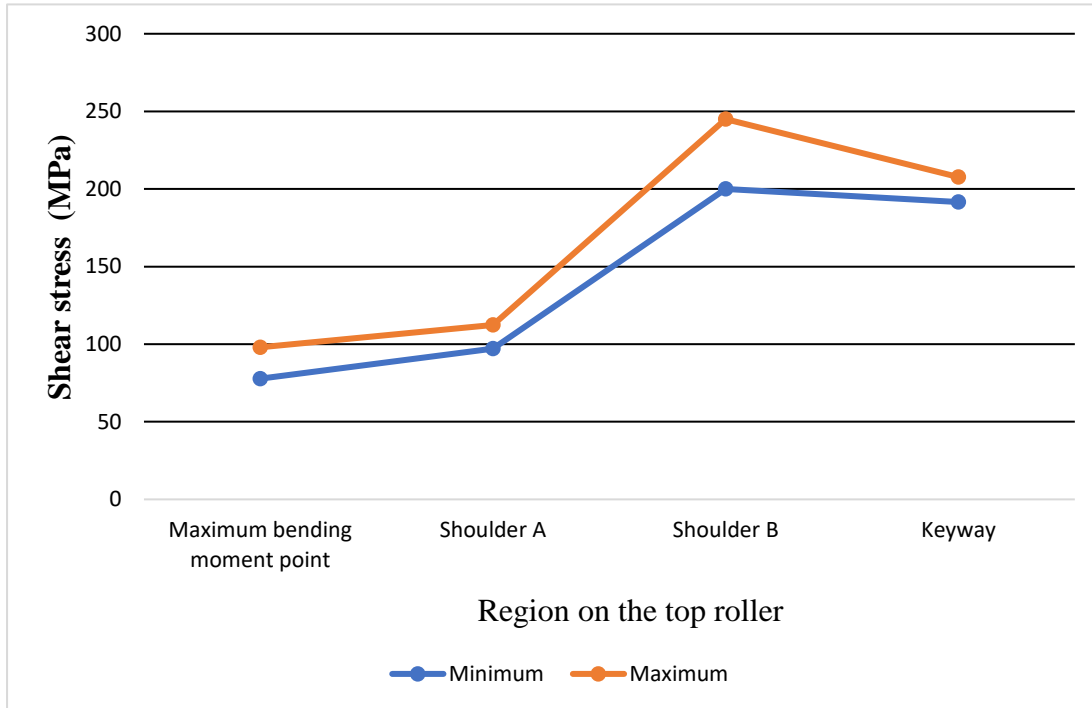
Figure 4.6: Stress distribution on different top roller sections

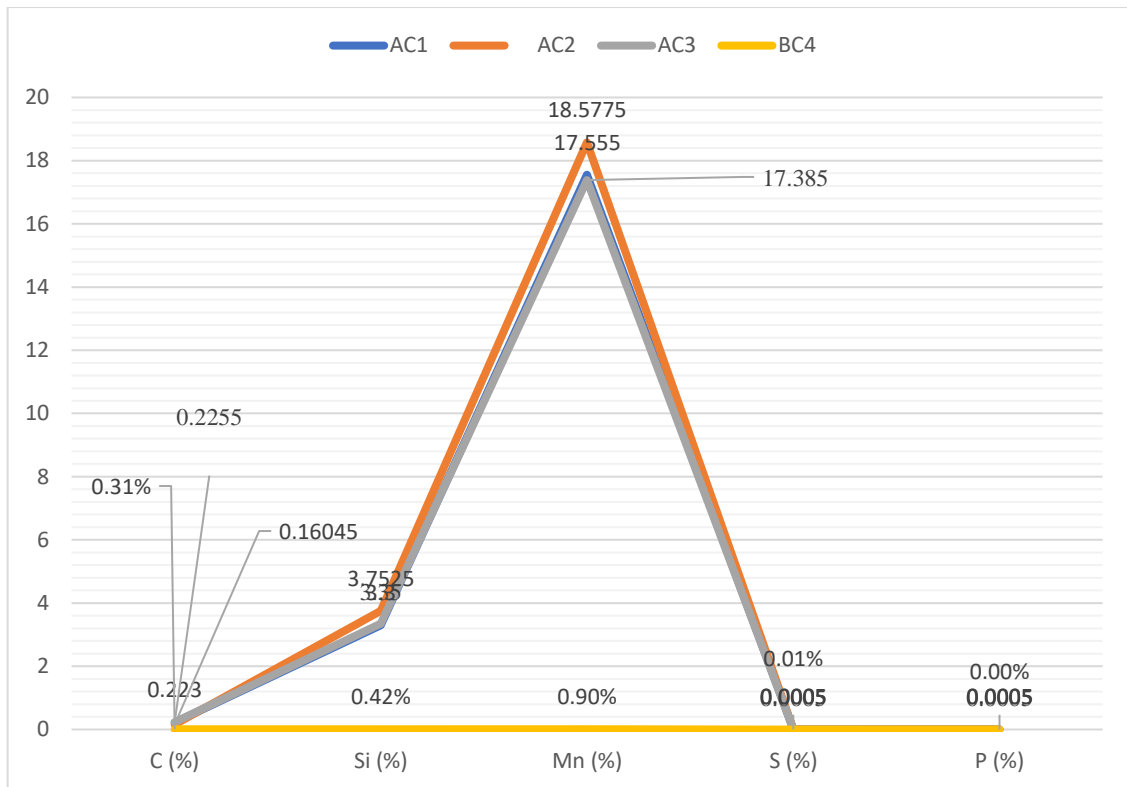
Specimen	C (%)	Si (%)	Mn (%)	S (%)	P (%)
AC1	0.223	3.3	17.555	0.0005	0.0005
AC2	0.16045	3.7525	18.5775	0.0005	0.0005
AC3	0.2255	3.35	17.385	0.0005	0.0005
BC4	0.3058%	0.4189%	0.8963%	0.0092%	0.0021%

Figure 4.15: Relative Average chemical compositions of the specimens

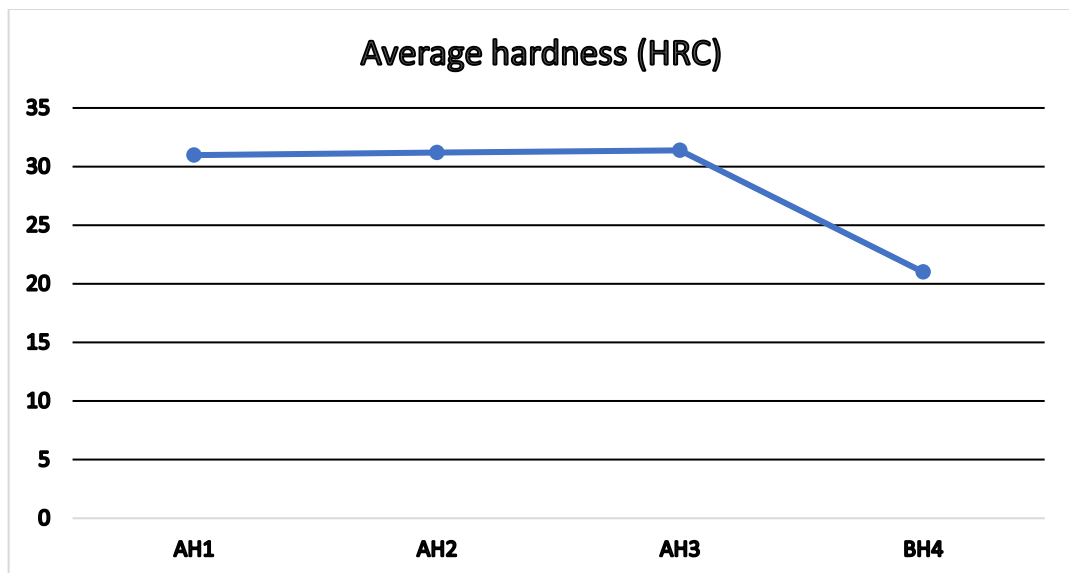
Specimen	Average hardness (HRC)
AH1	30.97
AH2	31.2
AH3	31.38
BH4	21

*Figure 4.16: Average hardness for the 4 failed shaft material specimens*

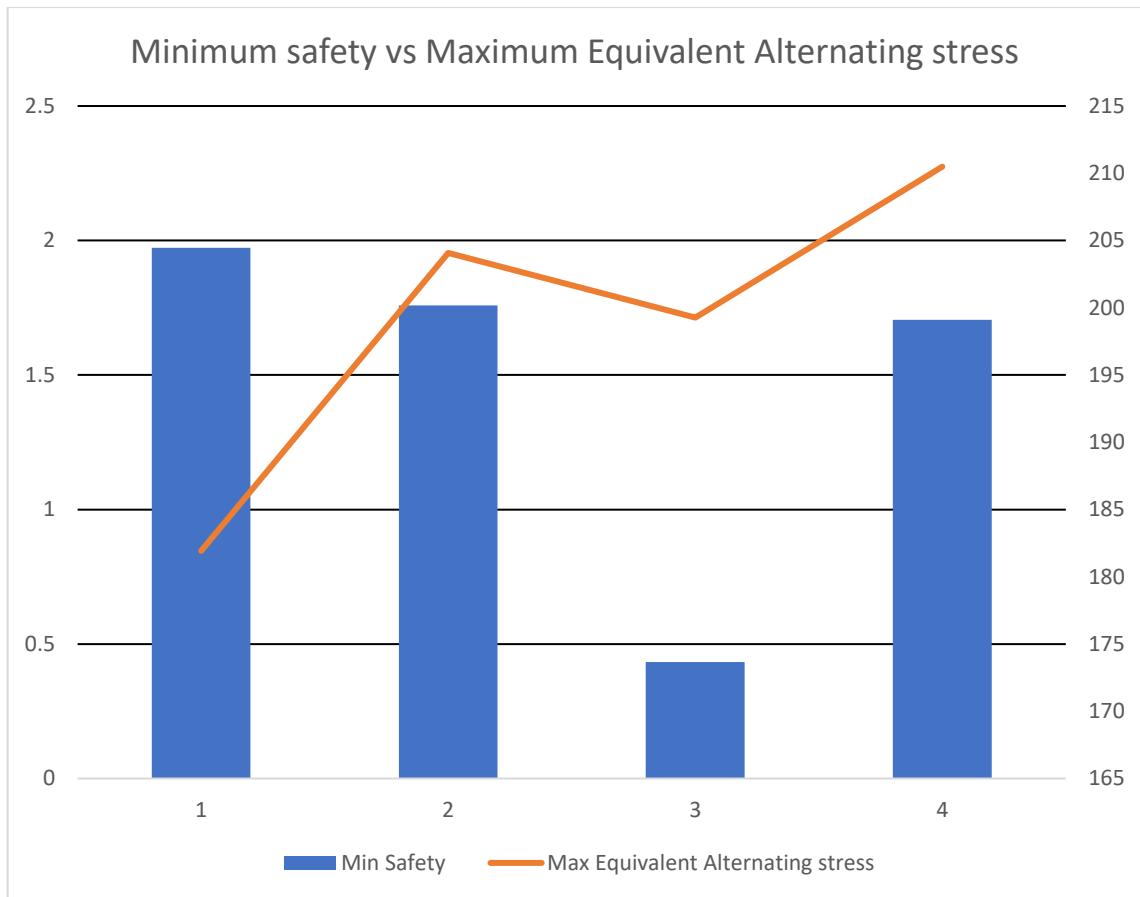
Figure 4.32: Minimum safety vs maximum Equivalent alternating stress

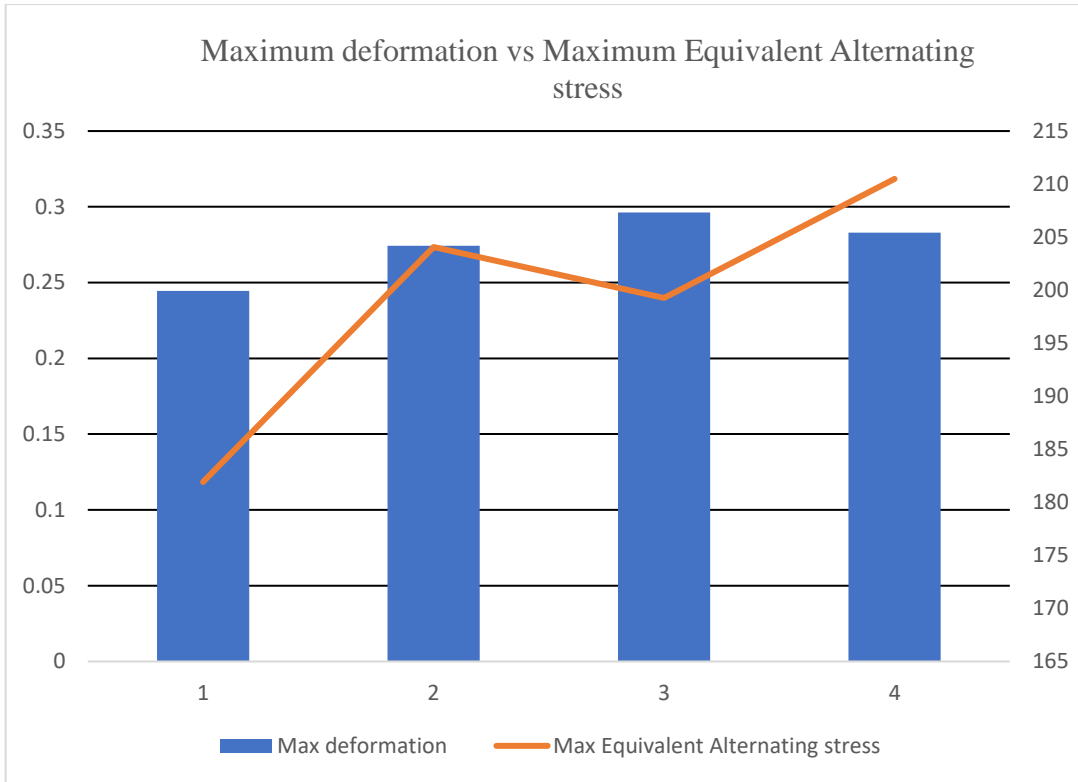
Figure 4.33: Maximum deformation vs maximum Equivalent alternating stress

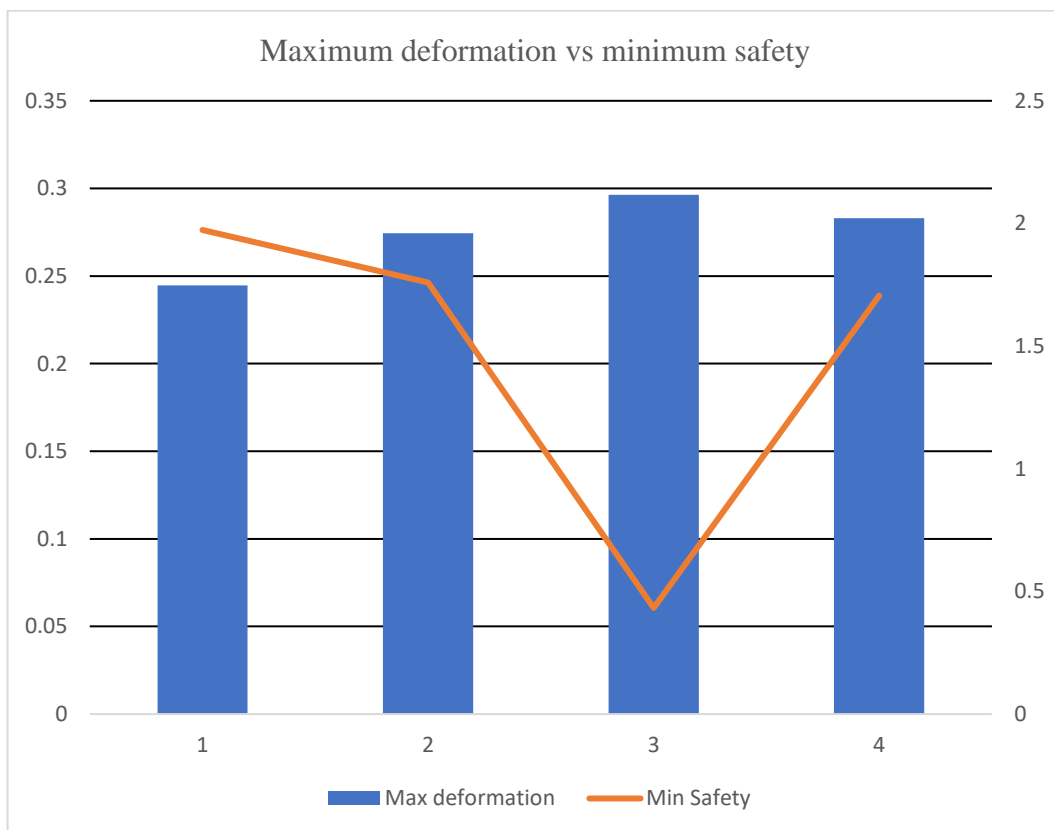
Figure 4.34: Maximum deformation vs minimum safety
