**ANALYZING THE FACTORS THAT AFFECT THE QUALITY
OF STAIRCASES: A CASE STUDY OF UNIVERSITIES IN THE
CENTRAL REGION, UGANDA**

**A DISSERTATION SUBMITTED TO KYAMBOGO
UNIVERSITY DIRECTORATE OF RESEARCH AND
GRADUATE TRAINING IN PARTIAL FULFILMENT OF THE
REQUIREMENTS FOR THE AWARD OF MASTER OF
SCIENCE IN CONSTRUCTION TECHNOLOGY AND
MANAGEMENT DEGREE OF KYAMBOGO UNIVERSITY**

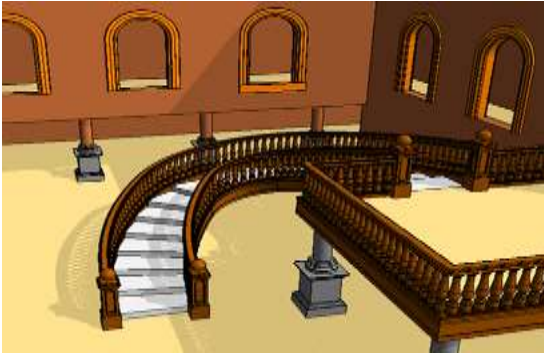
Figure 2.4(g): Circular stair

Circular stairs. These are custom made. The steps are trapezoidal in shape and have no centre column as in the case of spiral staircase.

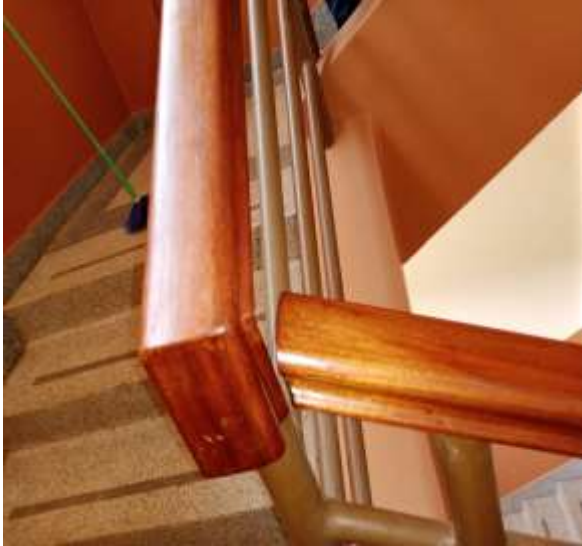
Photograph 1: Showing broken handrail

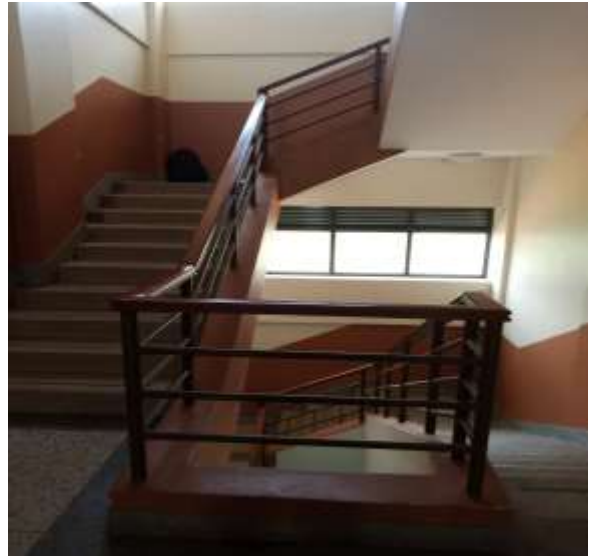
Photograph 2: Showing continuous handrail

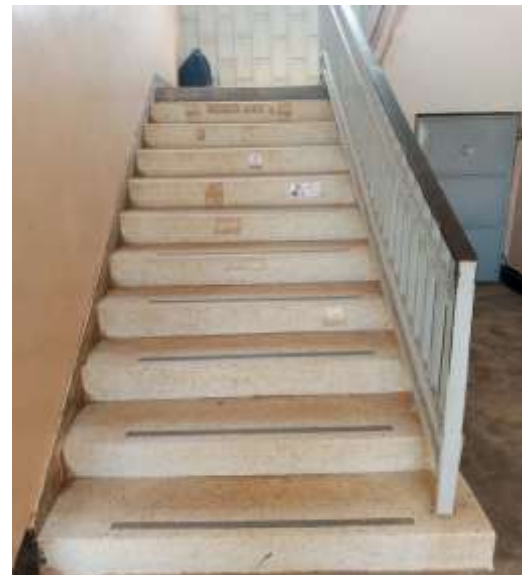
Photograph 4: Showing handrails on one side

It was noted that 96% of the staircases had handrails. From table 4.5, 34 stairs representing 68% had handrails on one side while 28% of the staircases had them on both sides. Only 4% did not have handrails at all. Forty staircases (80%) had widths greater than 1000mm. From the design requirements, all staircases which are more than 1000mm wide should have handrails on both sides. This means that 80% of the staircases were supposed to have

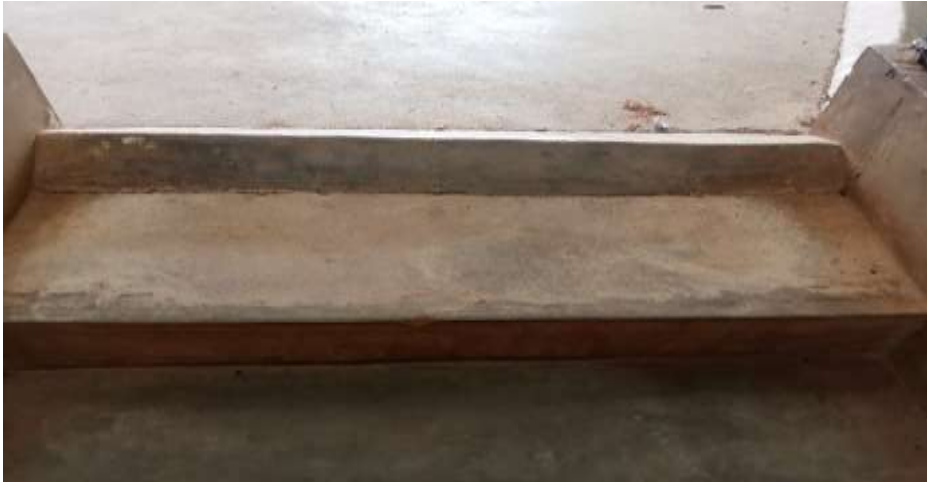
Photograph 5: Showing steps with a triangular barrier at the landing

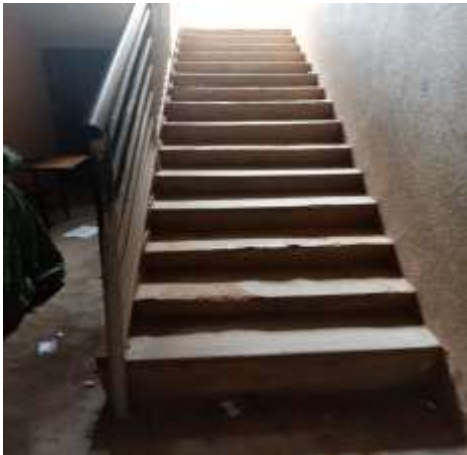
Photograph 6: Showing uneven steps

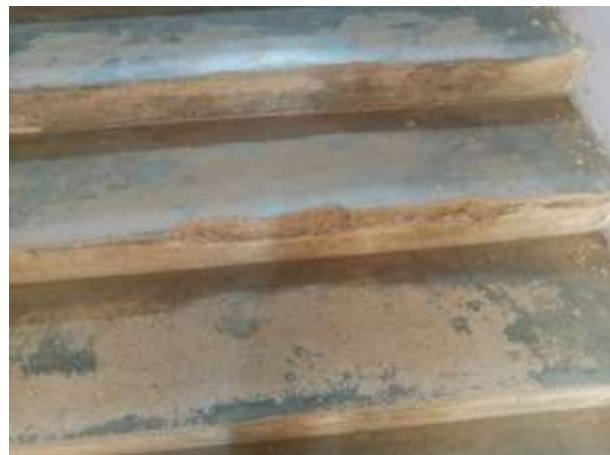
Photograph 7: Showing steps with broken edges

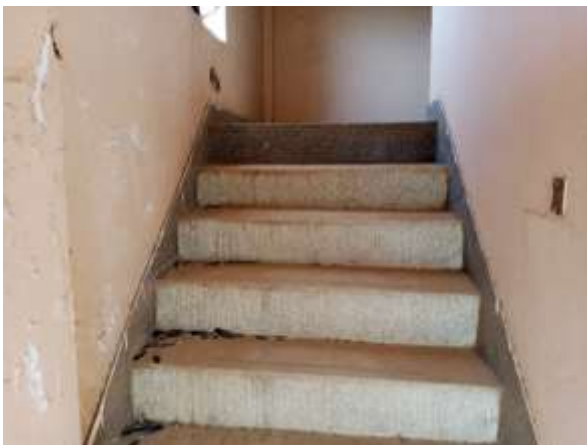
Photograph 8: Showing stair flight with uneven risers

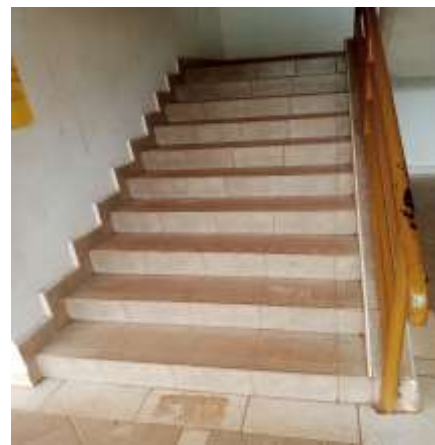
Photograph 9: Showing treads in a flight

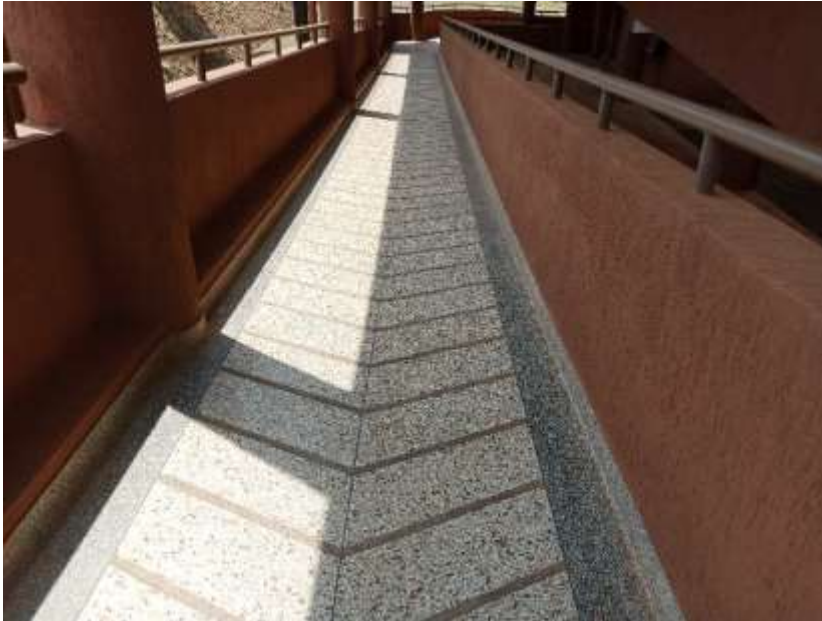
Photograph 10: Showing a well constructed ramp

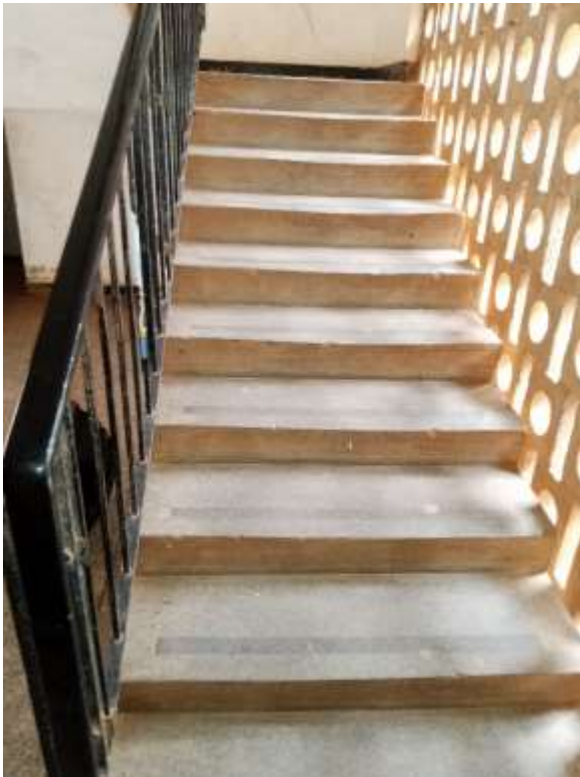
Photograph 11: Showing faded nosing contrast

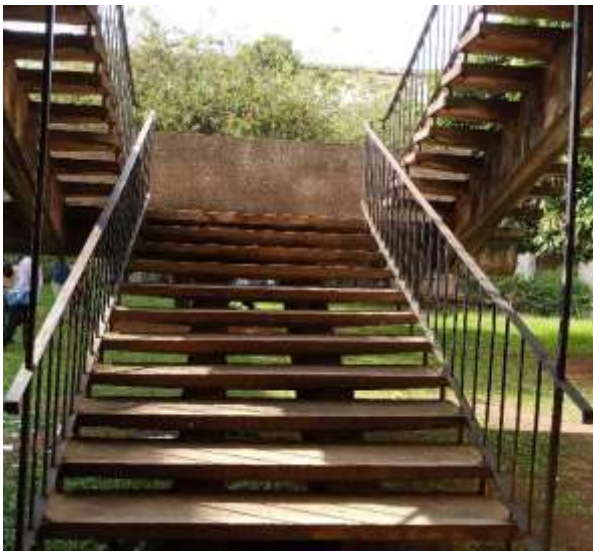
Photograph 13: Showing stair flight with open risers

Open risers in public buildings can increase the possibility of accidents to the users in which their feet can easily get stuck in between the steps causing falls. In this study, only 6% of the staircases were found to be open riser staircases. These were mainly found on the spiral staircases and another external stair No. 12 (BLDG 104-2). Since these were not the main staircases on the buildings in which they were used, they would have little impact on the safety of the users and hence did not affect the quality of the staircases as there were alternative staircases in these particular buildings.
