**ASSESSMENT OF VARIATION IN TREATED WATER QUALITY AND  
LINKAGE TO POSSIBLE INTRUSION OF CONTAMINANTS IN MAKINDYE  
DIVISION, KAMPALA, UGANDA**

**A DISSERTATION SUBMITTED TO KYAMBOGO UNIVERSITY DIRECTORATE OF  
RESEARCH AND GRADUATE TRAINING IN PARTIAL FULFILMENT OF THE  
REQUIREMENTS FOR THE AWARD OF MASTER OF SCIENCE IN WATER AND  
SANITATION ENGINEERING DEGREE OF KYAMBOGO UNIVERSITY**

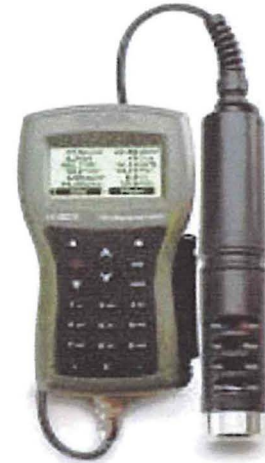
Figure 3-2: Hanna Meter HI 9828

In-situ water parameters were measured using a multi-parameter water quality meter (HANNA HI 9828; Figure 3-2) while samples collected were sent to the Public health Laboratory at Makerere University and Uganda Industrial Research Institute (UIRI), accredited laboratories for testing and analysis of water samples. Laboratory analysis was done for the following parameters; Faecal Coliforms, colour and turbidity.

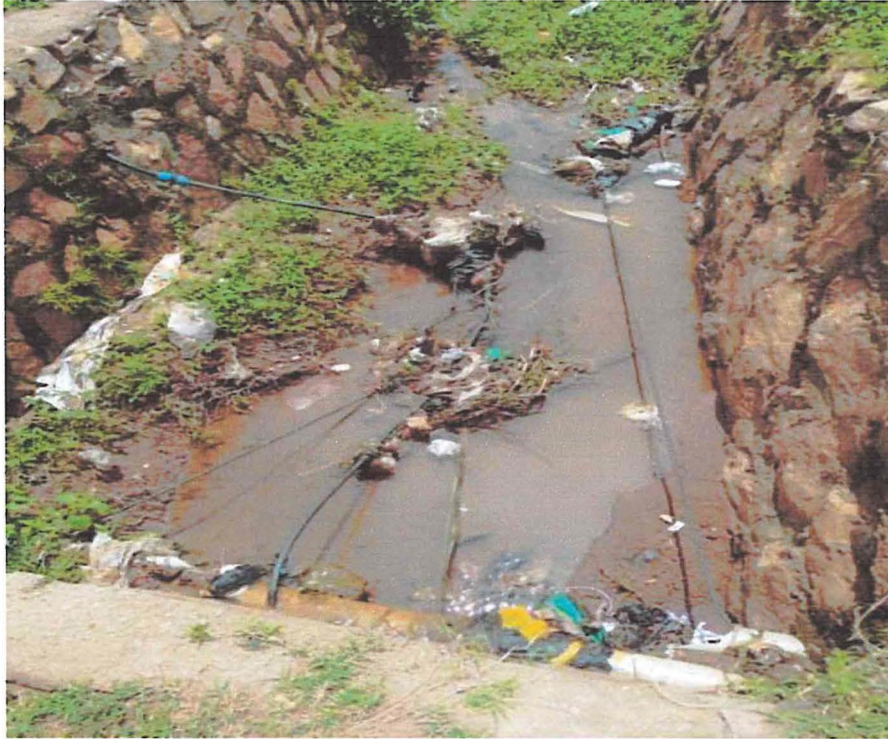
Figure 4-35: Pipe network in Soya

Contamination may be secondary, internal or external (Jachimowski, 2017). The external factors include intrusion from leakages and bursts while internal may be as a result of reactions and transformations (Figure 4-35). Water quality may be degraded due to different factors and transformations that take place within the pipe network, the service tanks, residential storage tanks and premise plumbing (NRC, 2006).
