**PERFORMANCE EVALUATION OF ROOF-MOUNTED PHOTOVOLTAIC
MODULES IN SELECTED RURAL SECONDARY SCHOOLS IN NORTHERN AND
EASTERN UGANDA**

**A DISSERTATION SUBMITTED TO THE DIRECTORATE OF RESEARCH AND
GRADUATE TRAINING IN PARTIAL FULFILMENT OF THE REQUIREMENTS FOR
THE AWARD OF THE DEGREE OF MASTER OF SCIENCE IN PHYSICS OF**

KYAMBOGO UNIVERSITY

OCTOBER, 2025

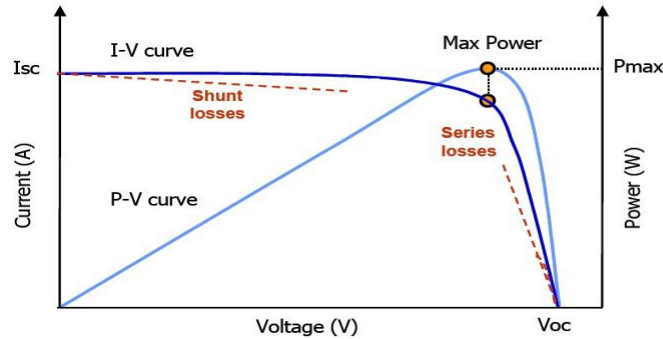
Figure 2.2: Sketch graph of current-voltage characteristics of a solar module.

It is important to determine I_{mp} and V_{mp} . These would be read and noted directly from the current and voltage axes (Figure 2.2) and used in the calculation of maximum power of the module as in Equation (2.4).

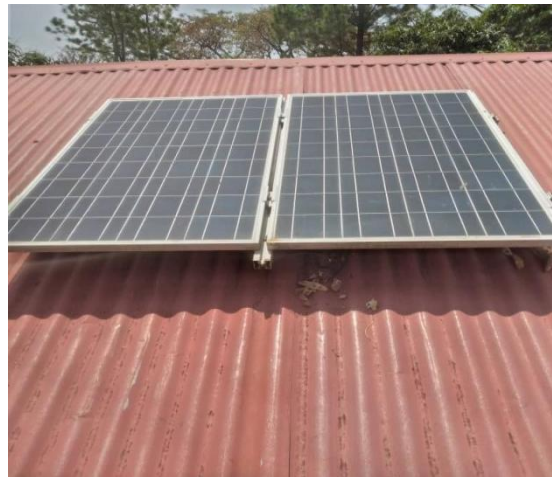
Figure 3.1: General arrangements of modules in a string.

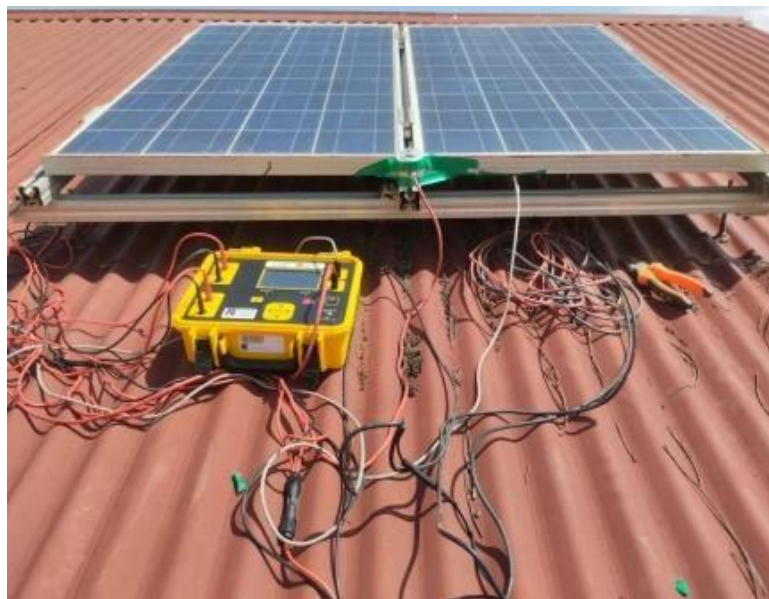
Figure 3.3: I-V Tracer connected to the modules at Orungo High School.

The pyranometer connected to the I-V Tracer was used to measure solar irradiance, and the thermocouple connected and placed at the back of the module, as shown in Figure 3.3, to measure

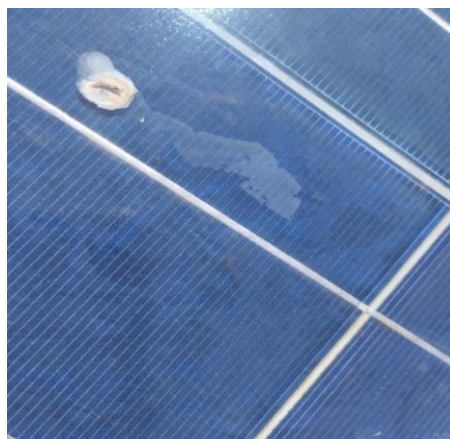
Visual inspection for module A at Orungo High School is presented in Table 4.1. Module A had dust and debris accumulated on it. Discolouration was present on the cell encapsulation of the module at Orungo High School. Accumulation of dust and debris results in shading of the modules, hence affecting the maximum power output of the module. Visual inspection results for module B at Orungo High School, presented in Table 4.2, showed no physical defect except the presence of Bird droppings, as in Figure 4.1, with a lot of dust and debris accumulated.

Figure 4.1: Bird dropping on the module B Orungo SS.

Accumulation of dust and debris results in physical shading of the module, and this affects the functionality of the module [70].

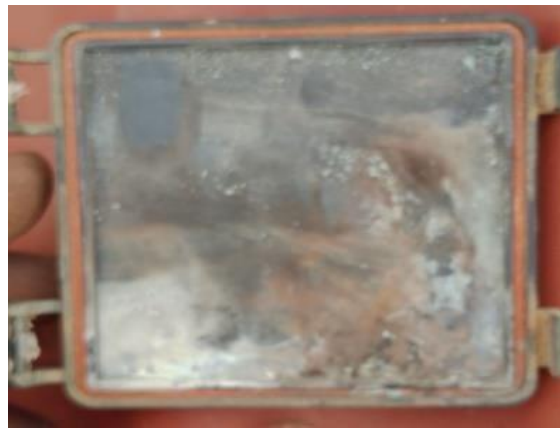
Figure 4.5: Diode cover corroded at Adwari Secondary School.

In a solar cell circuit, the diode is typically connected in a reverse bias configuration to prevent any reverse current flow. It can act as a protection mechanism, blocking the current from flowing back into the solar cell when it is not receiving sunlight. When the diode becomes destroyed, as shown in Figure 4.5, it becomes an open circuit with no current flowing through the diode or the solar cell. This could be the reason why module B did not give any power output.

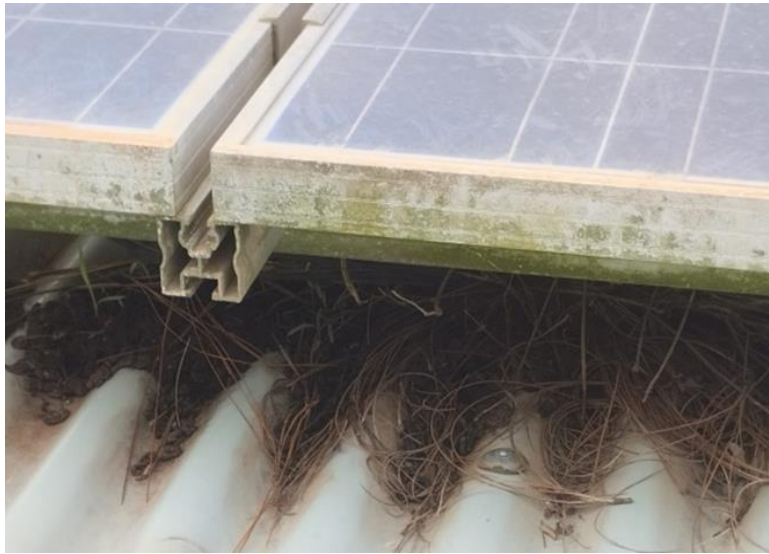
Figure 4.6: Bird's nest under the modules at Akii Bua Comprehensive Secondary School.

The nests and debris can act as an insulating layer [76], trapping heat under the PV module. This heat buildup can increase the operating temperature of the solar cells, reducing their efficiency and potentially causing damage over time [77]. Nests and other materials can also introduce additional weight and pressure on the solar module, potentially leading to damage to the diodes or other components within the module. Damage to the diodes can disrupt the flow of electricity and negatively impact the overall power generation of the module [78].

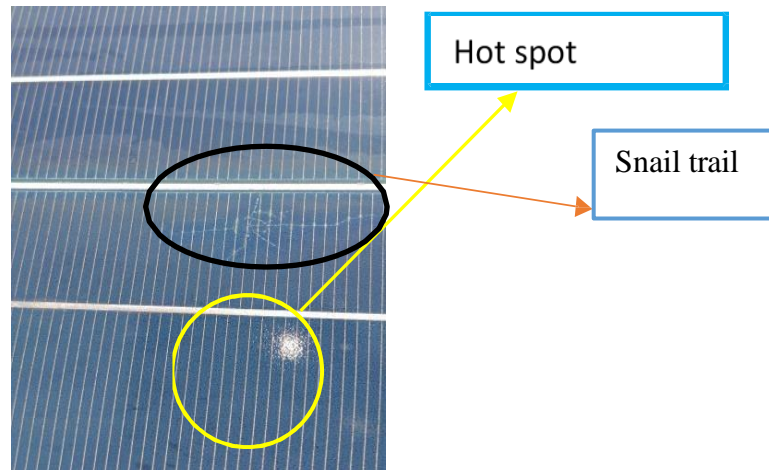
Figure 4.7: Module with hot spot and snail trail at Katine SS.

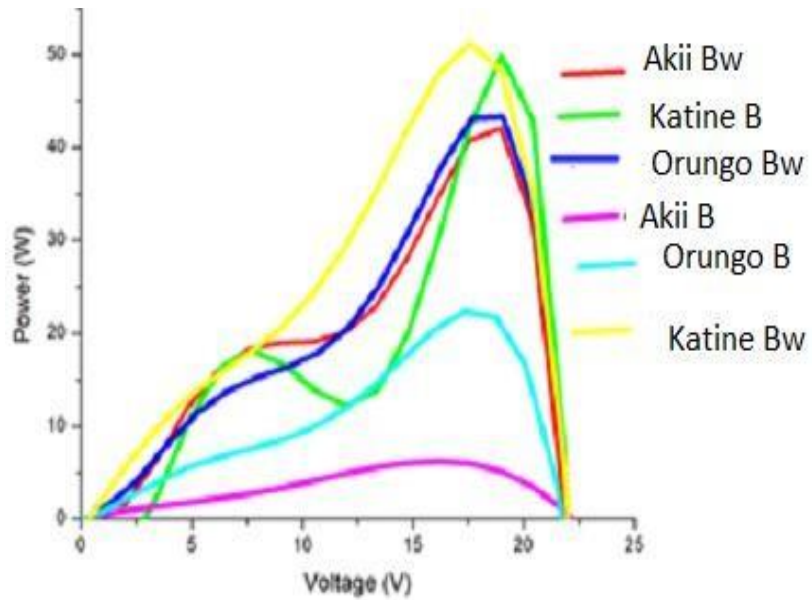
Figure 4.14: P-V curves for module B.

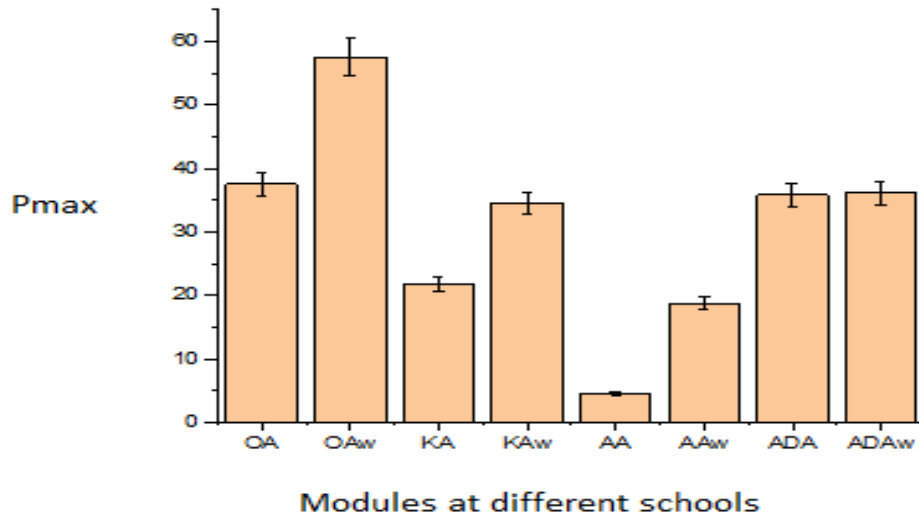
Figure 4.16: Maximum power of modules A before and after washing.

In Figure 4.16, OA represents Orungo High School module A before washing, OA_w after washing, KA represents Katine SS module A before washing, KA_w after washing, AKA represents Akii Bua Comprehensive SS module A before washing, AKA_w after washing, and ADA represents Adwari SS module A before washing and ADA_w after washing.

The results revealed that washing the modules increases the module power output. This is because some physical particles which had accumulated on the modules were washed away by water, hence more irradiance could reach the module cells and generate power. The increment was more pronounced at module A installed at Akii Bua Comprehensive SS (73.7%), followed by Katine S.S (37.1%), Orungo High School (34.8%), and Adwari S.S (1.4%).

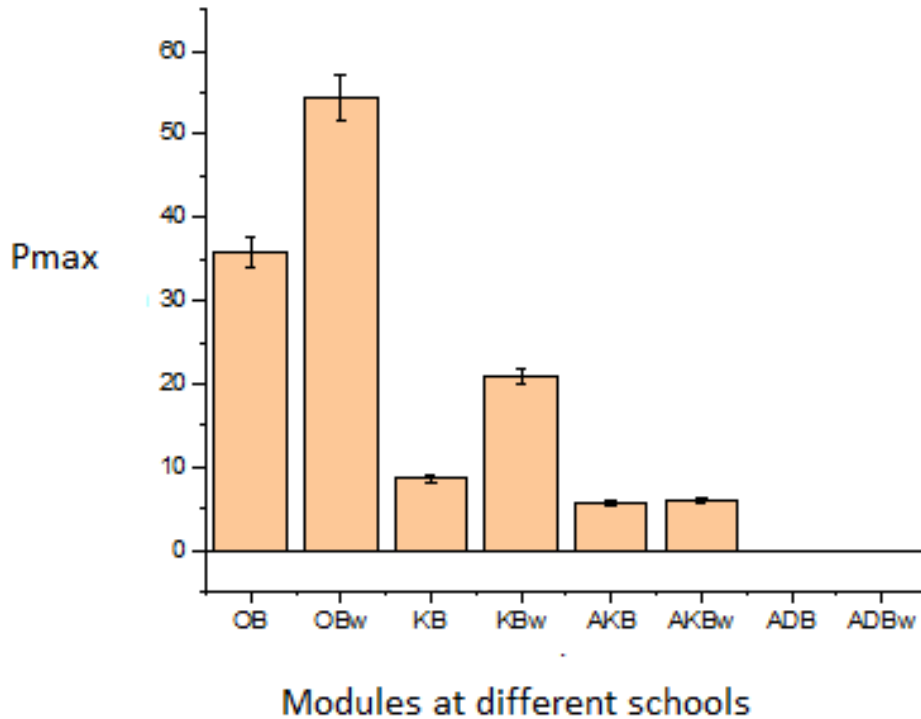
Figure 4.17: Module B of different schools.

In Figure 4.17, OB represents Orungo High School module B before washing, OB_w after washing, KB represents Katine SS module B before washing, KB_w after washing, AKB represents Akii Bua Comprehensive SS module B before washing, AKB_w after washing, and ADB represents Adwari SS module B before washing and ADB_w after washing.

The results indicated that washing the modules increases the module power output. The increment was more pronounced at Katine SS (57.1%), followed by Orungo High School (33.3%), Akii Bua Comprehensive SS (5.9%), while module B at Adwari SS didn't give any power output. The inability to generate power by module B at Adwari SS could be attributed to the current limiting features like cracks, black spots, diode failure, and snail trails, which were detected on the module by visual inspection.

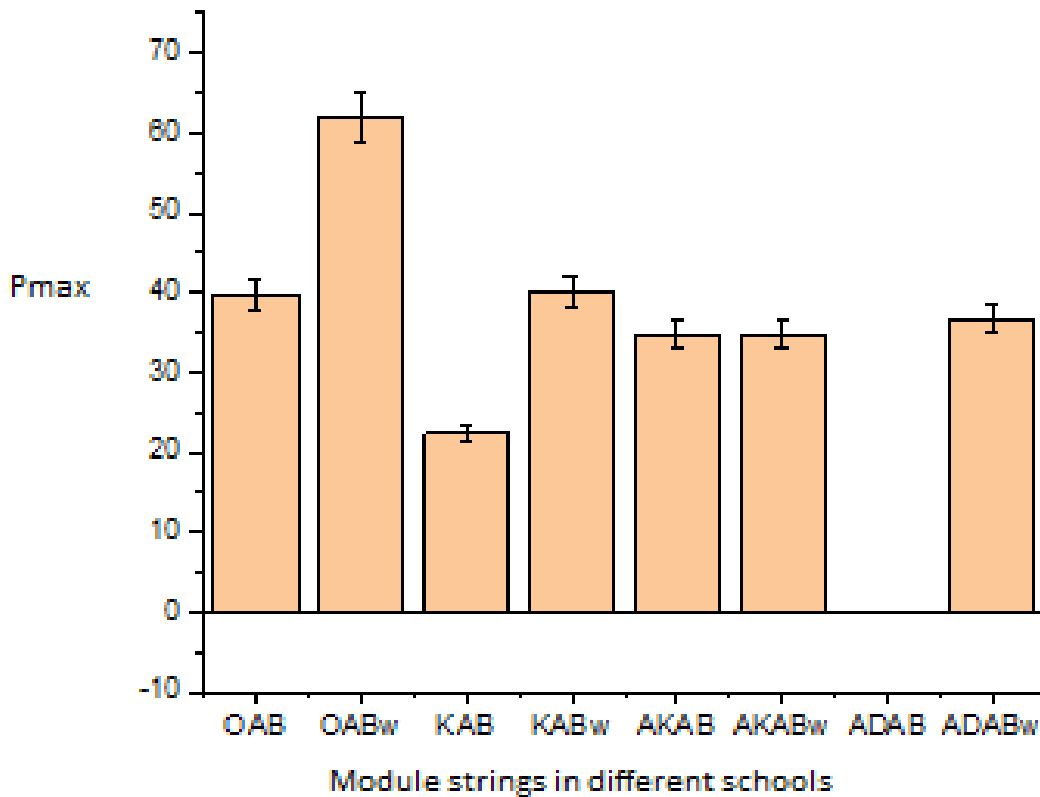
Figure 4.18: Maximum power of the module strings AB before and after washing.

In Figure 4.18, OAB represents Orungo High School module string AB before washing, OAB_w after washing, KAB represents Katine SS module string AB before washing, KAB_w after washing, AKAB represents Akii Bua Comprehensive SS module string AB before washing, AKAB_w after washing and ADAB represents Adwari SS module string AB before washing and ADAB_w after washing.
