**QUANTITATIVE ASSESSMENT OF NON-REVENUE WATER PREVALENCE IN  
NYARWODHO GFS IN UGANDA**

A DESERTATION SUBMITTED TO THE DIRECTORATE OF RESEARCH  
AND GRADUATE TRAINING IN PARTIAL FULFILMENT OF THE  
REQUIREMENTS FOR THE AWARD OF A DEGREE  
OF MASTER OF SCIENCE IN WATER AND  
SANITATION ENGINEERING  
OF KYAMBOGO UNIVERSITY

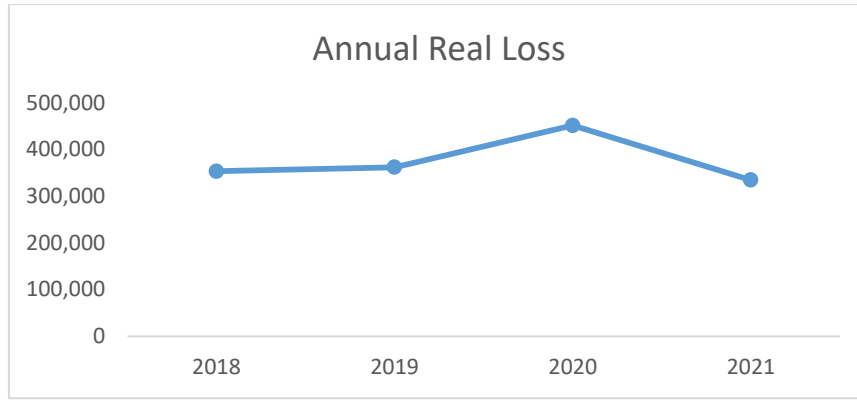
**Figure 4-2:** average cumulative Annual Real losses for the four year period

The cumulative average annual NRW for the four years was computed at 358,205.3m<sup>3</sup> out of the systems input volume of 443,267.8m<sup>3</sup>/year. Water billed and sold only amounted to 19% of the total water supplied. 2020 saw the most annual actual losses, totaling 452,010 m3, while 2021 saw the lowest, totaling 334,996 m3. Details are presented (Figure 4-2)

The average annual water losses were; 374064 m<sup>3</sup> in 2018, 353,859m<sup>3</sup> in 2019, 362,416m<sup>3</sup>, in 2020, and 334,996m<sup>3</sup> in 2021 respectively. The year 2018 exhibited the highest loss when the system was handed over to the operator which indicates a number of challenges as the scheme was yet new and being such a vast coverage there were so many issues to address.

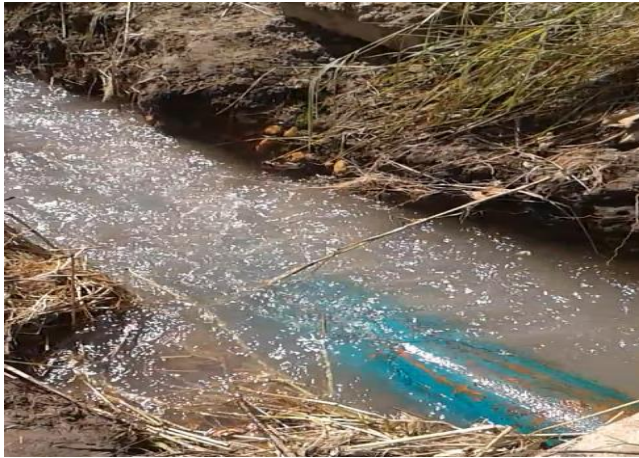
Burst on the PVC and G.I interlink

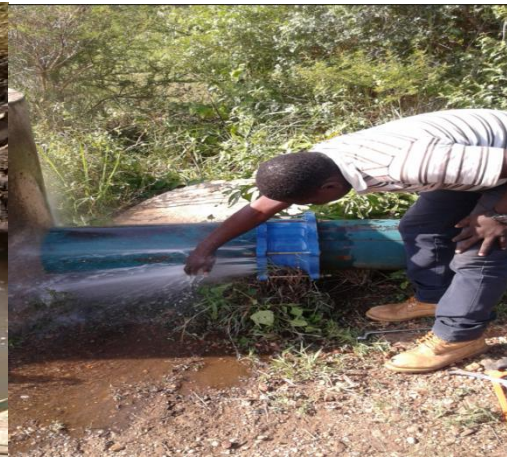
Leakage on the pipe joint

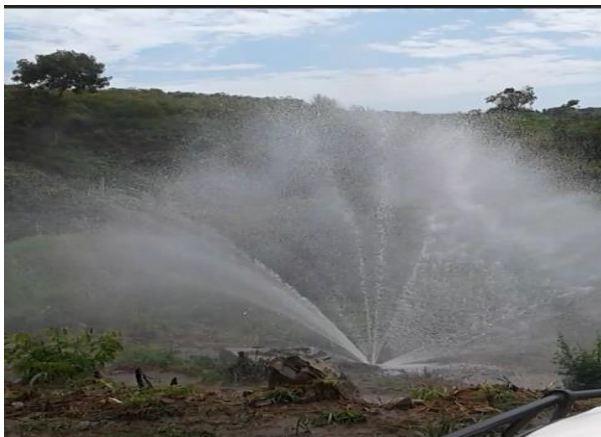
Burst on the mains

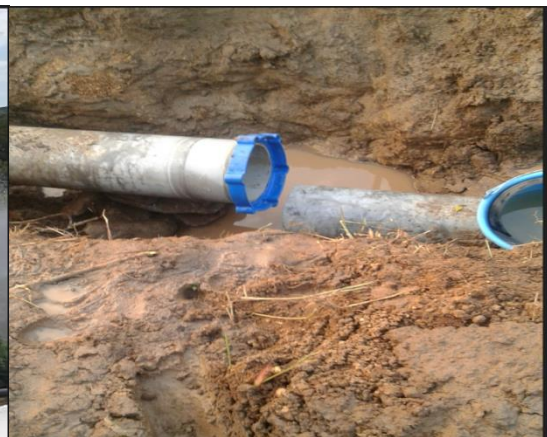
Repair works on PVC pipes

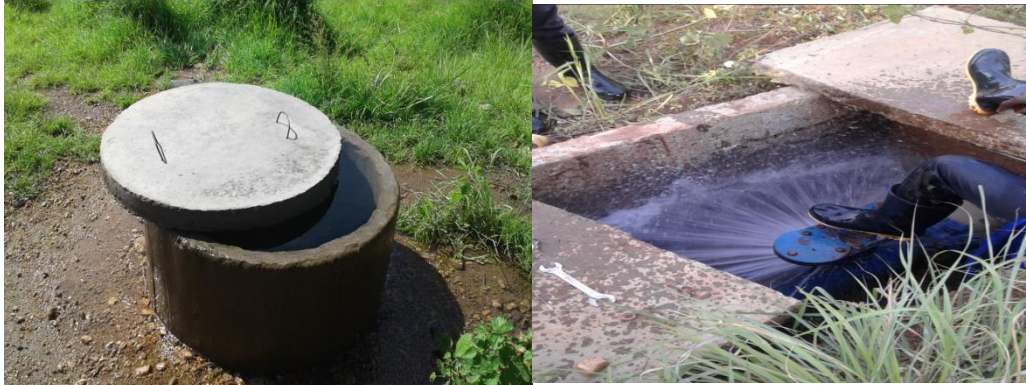
Continuous losses at the air valve

Loss from the air valve

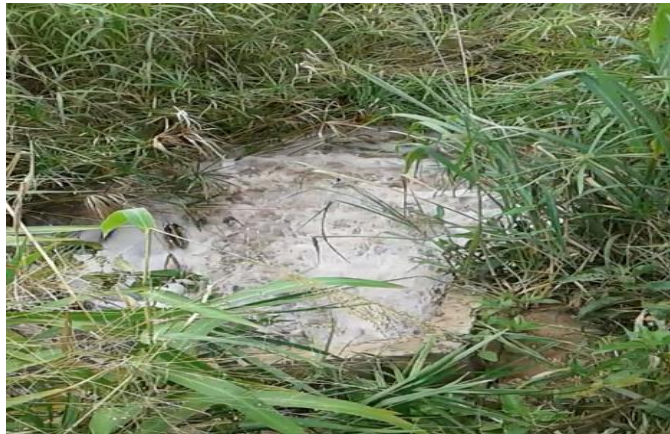
Loss from Washout

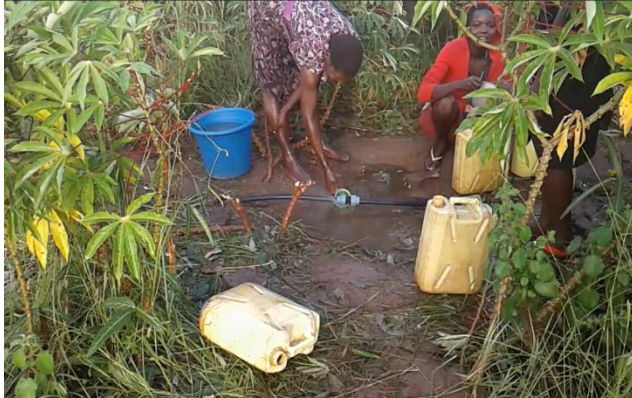
Locals fetch from a burst point

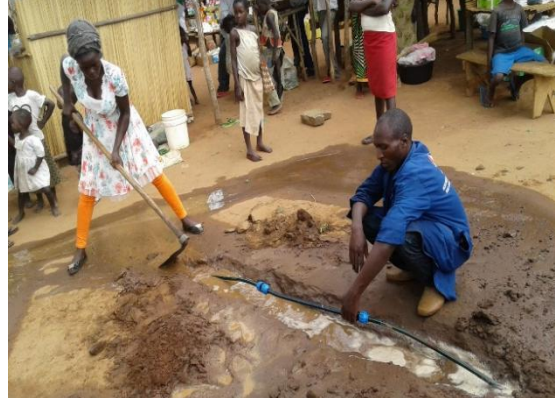
Repair works on burst

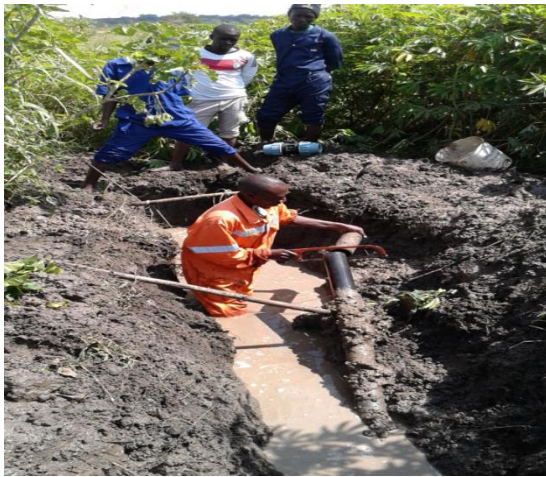
Repair works on Distribution line

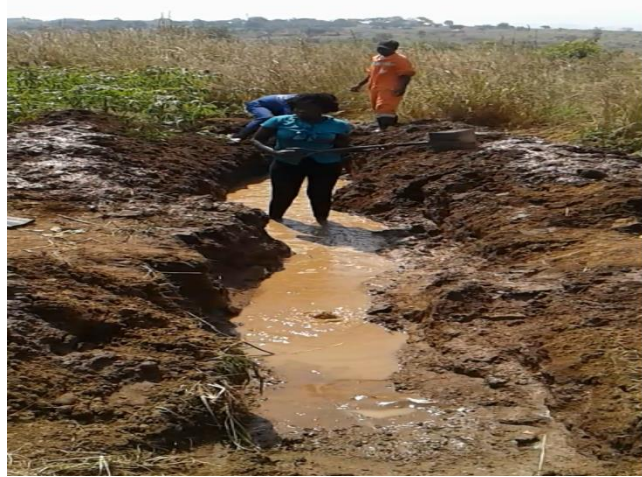
Pipe exposure to facilitate repair

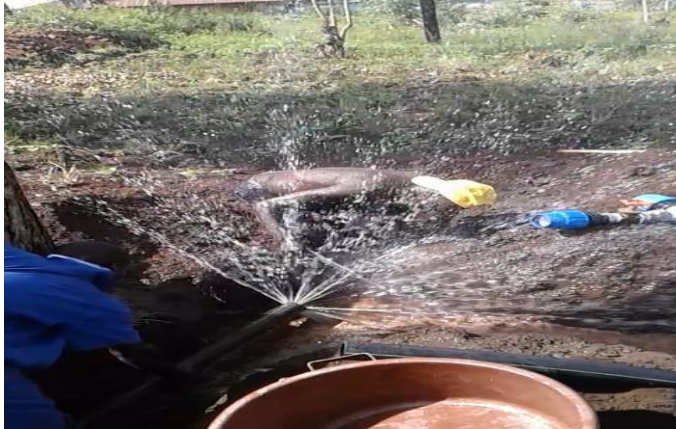
Losses from a vandalized pipe

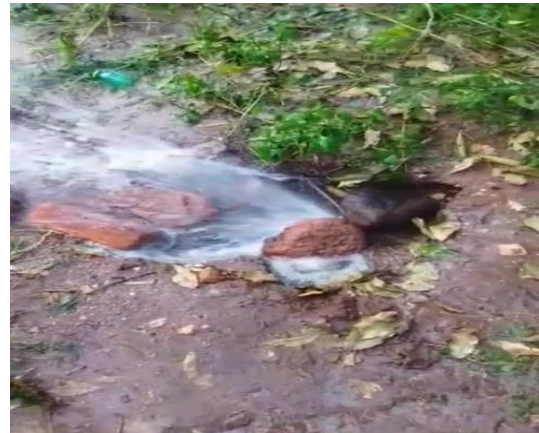
Losses from a pipe that has been cut
