**ASSESSMENT OF MOISTURE RELATED DEFECTS IN MASONRY  
WALLS**

**A DISSERTATION SUBMITTED TO DIRECTORATE OF RESEARCH  
AND GRADUATE TRAINING IN PARTIAL FULFILMENT FOR  
THE REQUIREMENTS FOR THE AWARD OF A DEGREE IN  
MASTER OF SCIENCE IN STRUCTURAL ENGINEERING OF  
KYAMBOGO UNIVERSITY**

**APRIL, 2024**

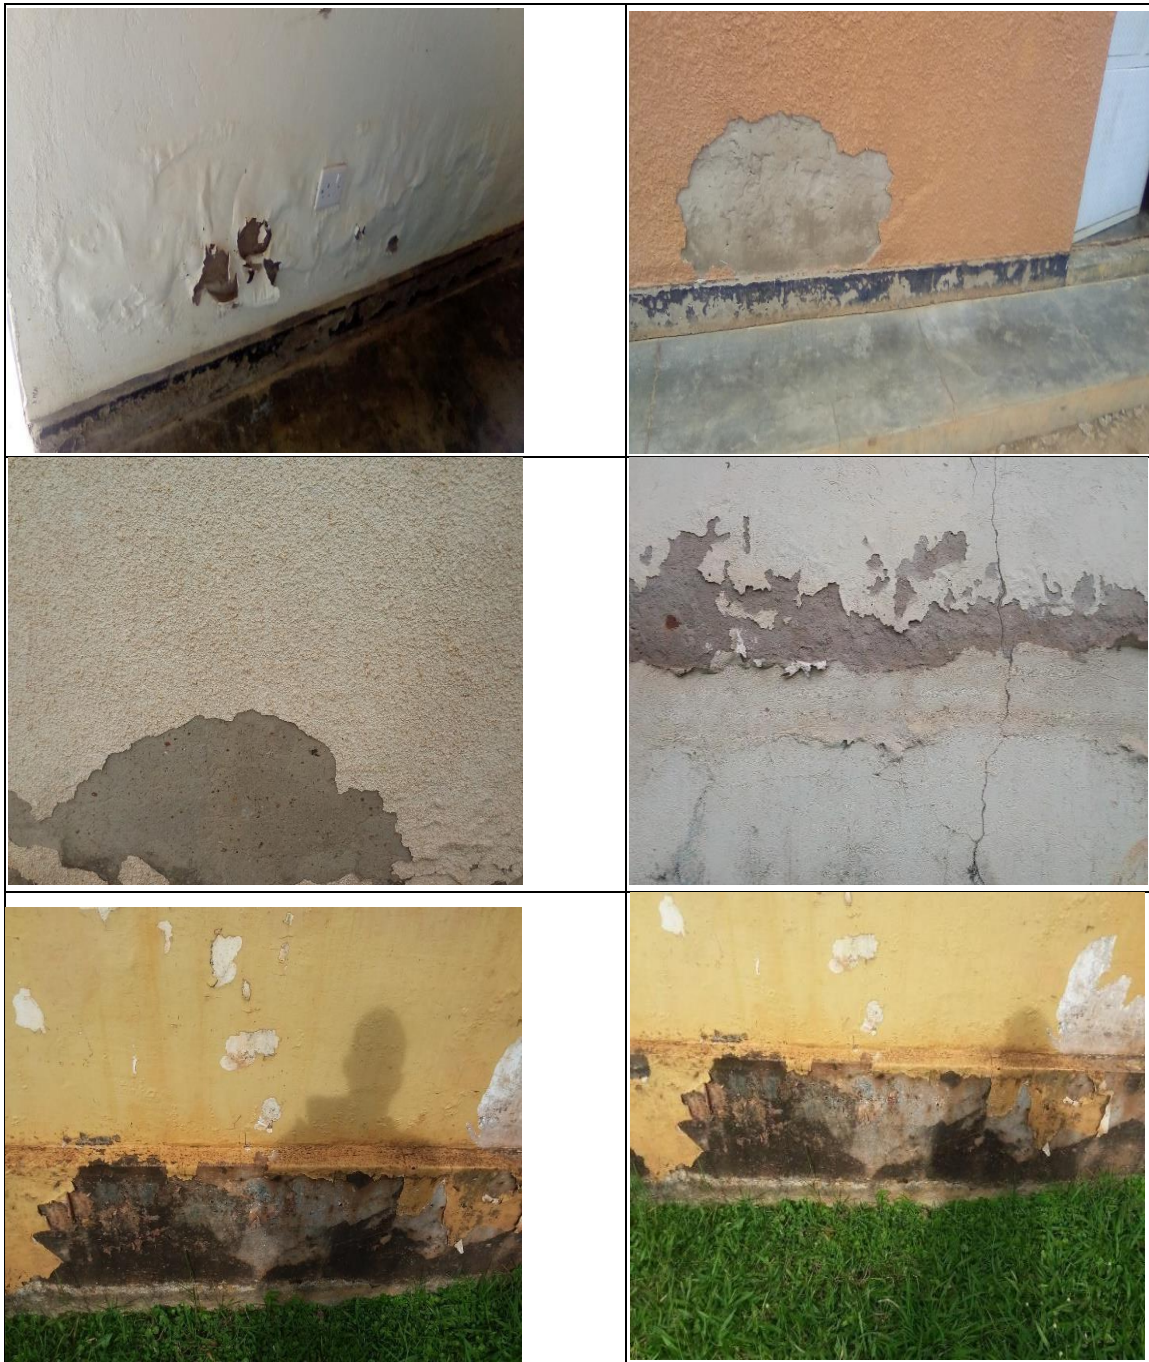
**Figure 1.1: Defects in masonry walls**

The majority of buildings, built lately as shown in Figure 1.1 above, had widespread flaws that are envisioned in terms of; peeling paint and plaster, colored stains (insoluble salts generated) on wall surfaces, and loss of aesthetic among others, which poses a big problem (Ercio & Hipolito, 2014). This is connected to water infiltration and can be linked to capillary rise, seepage through the materials, inadequate construction techniques, poor quality of materials used in construction (Maysum, 2022). Buildings constructed in the 1960s and 1970s, never experienced as much of this observation of water penetration (Brown & Williams, 1996). A systematic illustration of buildings affected by water penetration into buildings in Northern Uganda are as shown in Table 1.1 below;

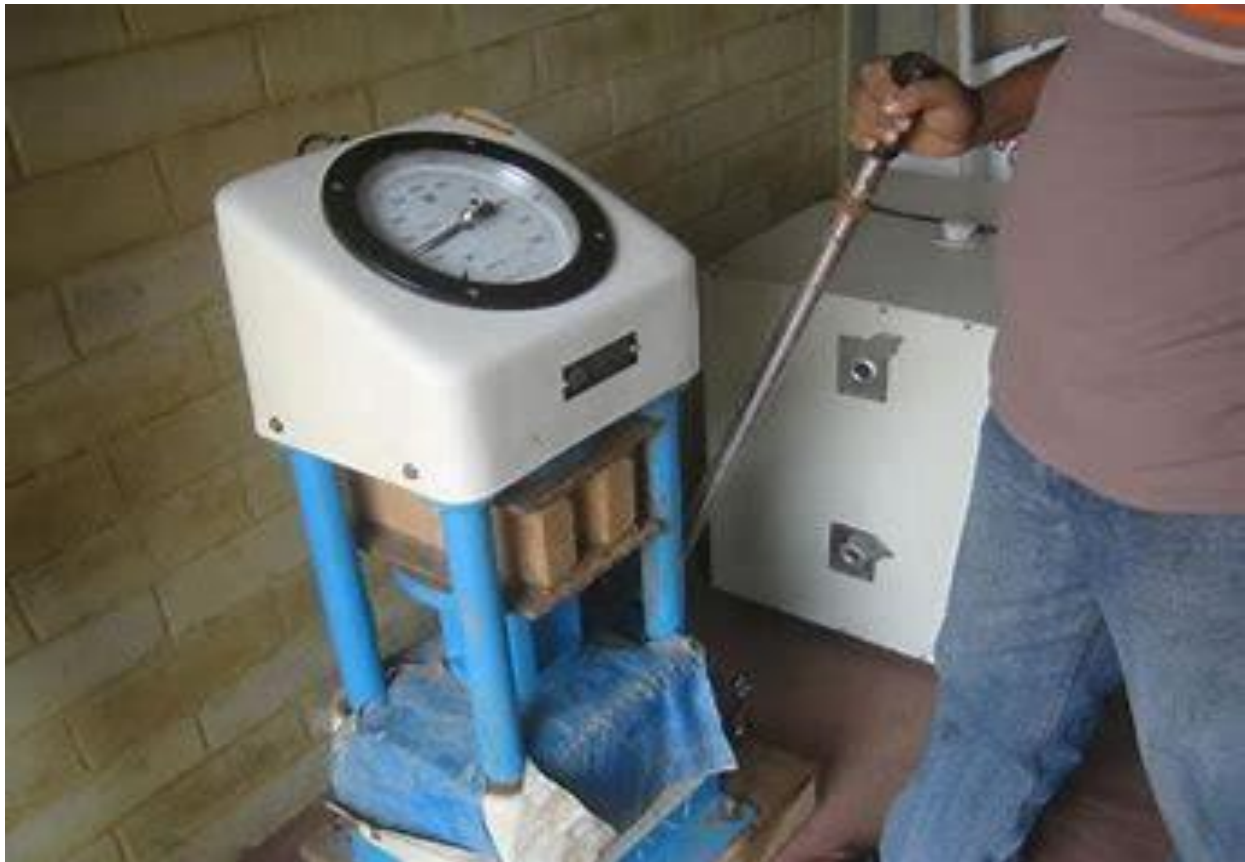
- a) The cylindrical pipe 50mm diameter, 2mm thick, and 300mm length, plus a moisture can
- b) 10kg hammer, and spatula
- c) 440mm chrome chisel, and thermometer
- d) 300 x 300 x 10 mm wooden board, fix to the wall to receive the sample to be cored
- e) An oven for drying of sample
- f) Crucible, for heating the sample in an oven
- g) Analytical balances, for weighing the sample
- h) Compressive strength measuring equipments
- i) Rebound hammer
- j) Compressive Strength Measuring Machine. The compressive strength measuring machine, & sample ordinary clay bricks measuring; 230 x 110 x 70 mm, are shown in **Figure 3.2** below;

**Figure 3.2: Compressive Strength Measuring Machine**

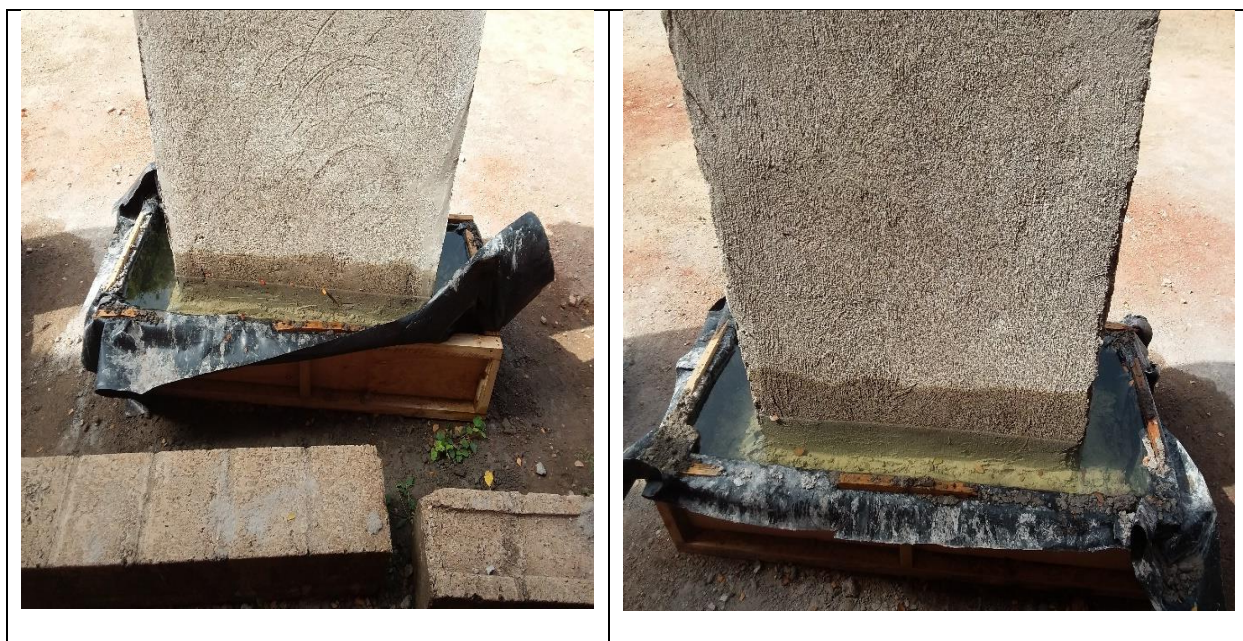
**Figure 3.5: Photo of Selected Models**

The DPC was made to coincide with the brick wall thickness. The rise of water through the finishes was monitored, and moisture content determination was carried out from 7:00am to 8:00am on a daily basis. After 10 days, the moisture rise remained constant. After 3 months, when the rise had stabilised, final testing was done.

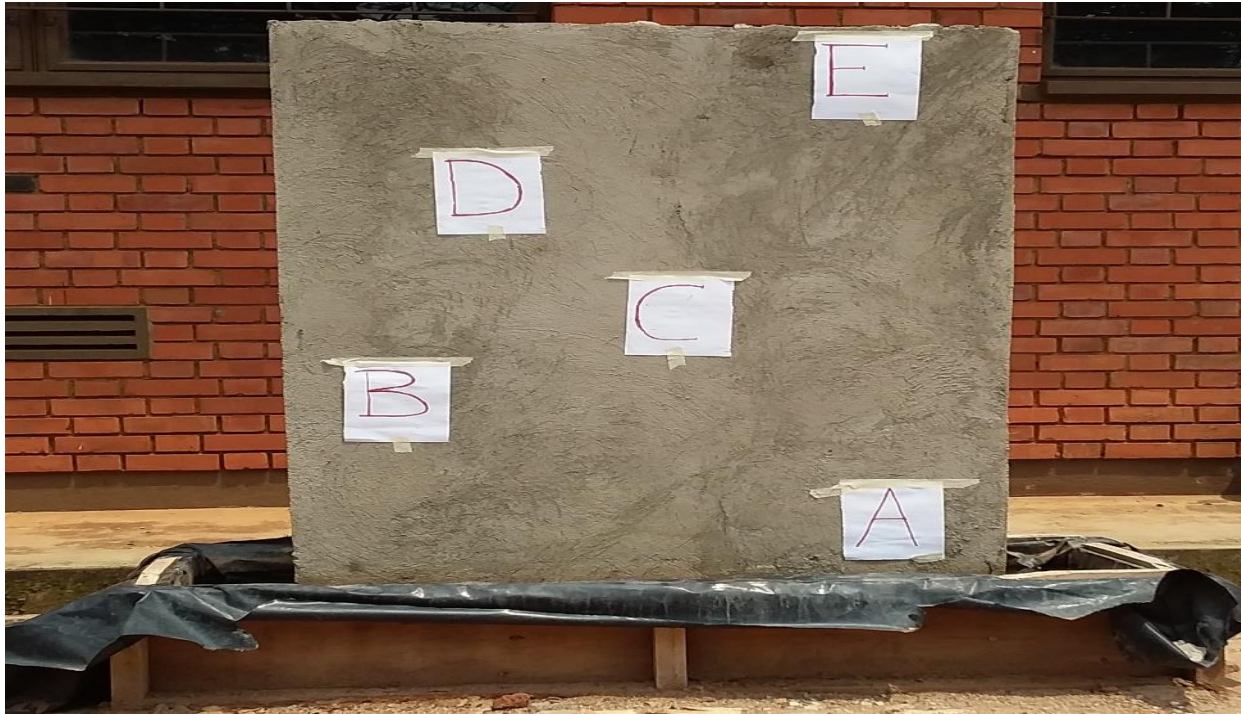
**Figure 3.7: Selected points on the face of one of the models, without water**

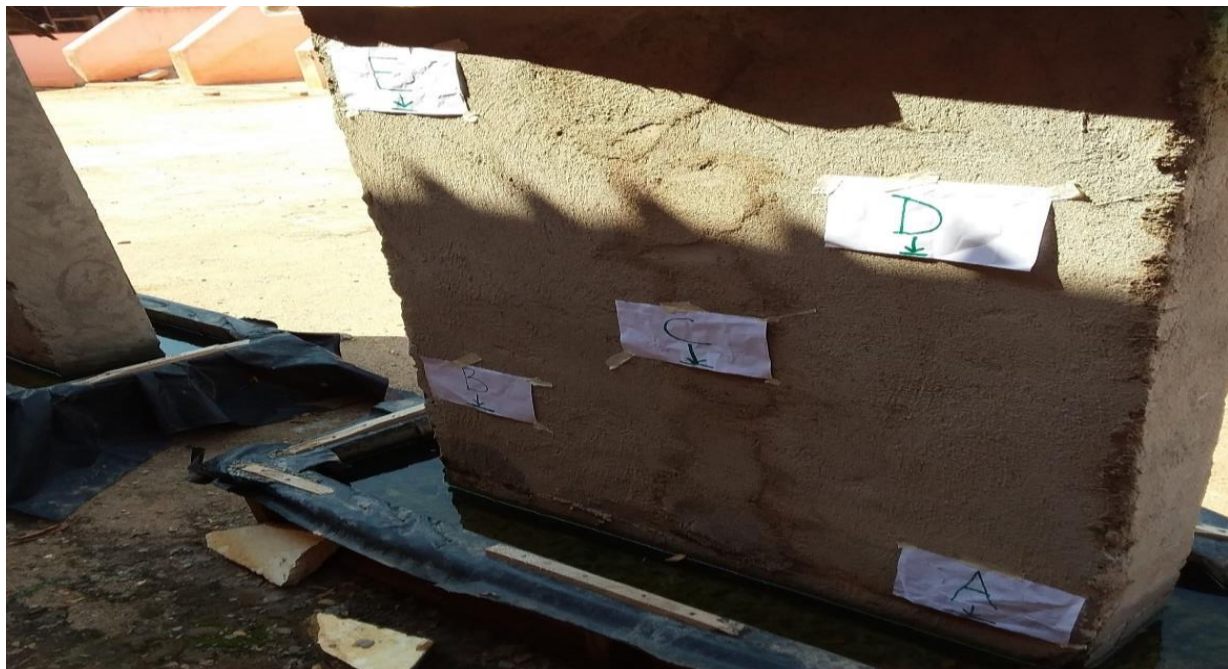
**Figure 3.8: Selected points on the face of one of the models, with water**

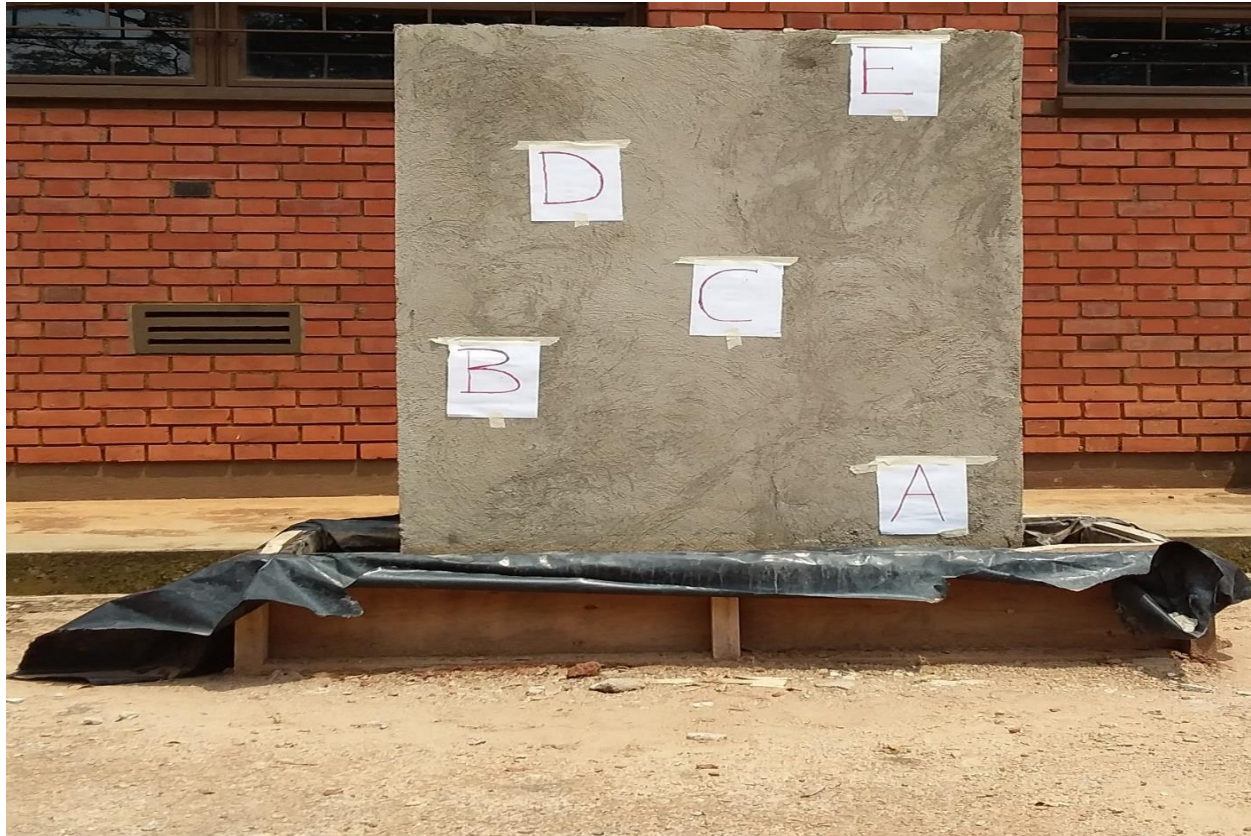
**Figure 4.1: Sample plaster taken from different spots on the face of model 5 outdoor 1 cement sand ratio 1:3**

While the moisture content of the model with water fed into the trough changes with height, as shown in Figure 4.1, the moisture content of the model without water on the trough, as shown in Figure 4.2, remains almost constant as the height increases. The moisture content was high at the DPC level (point A), and the value gradually decreases through points B, C, D, and E. This finding demonstrates how capillarity allowed moisture to ascend the wall. This offers a rationale for moisture related masonry flaws in walls. This serves as evidence for the study's focus, which was the rise in moisture through brick walls.

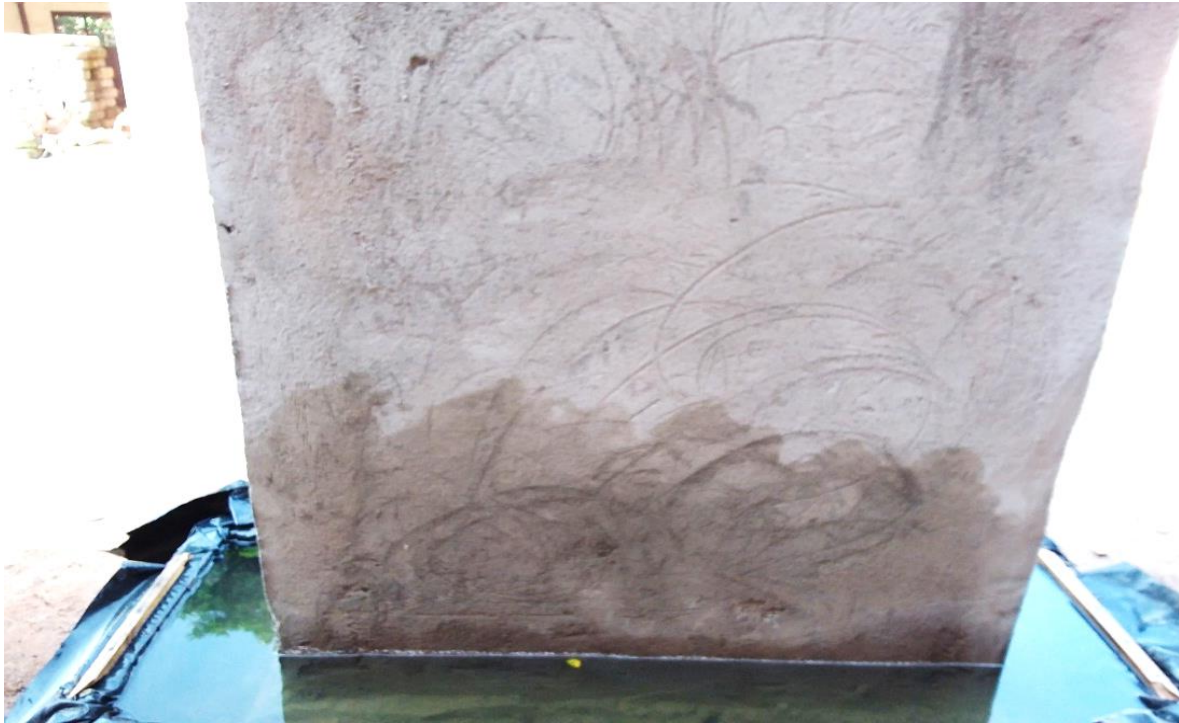
Moisture was observed to rise through the wall. And after 72 days, the rise was as shown in the photo Figure 4.26 below;

**Figure 4.26: Photo of moisture rise in one of the models**

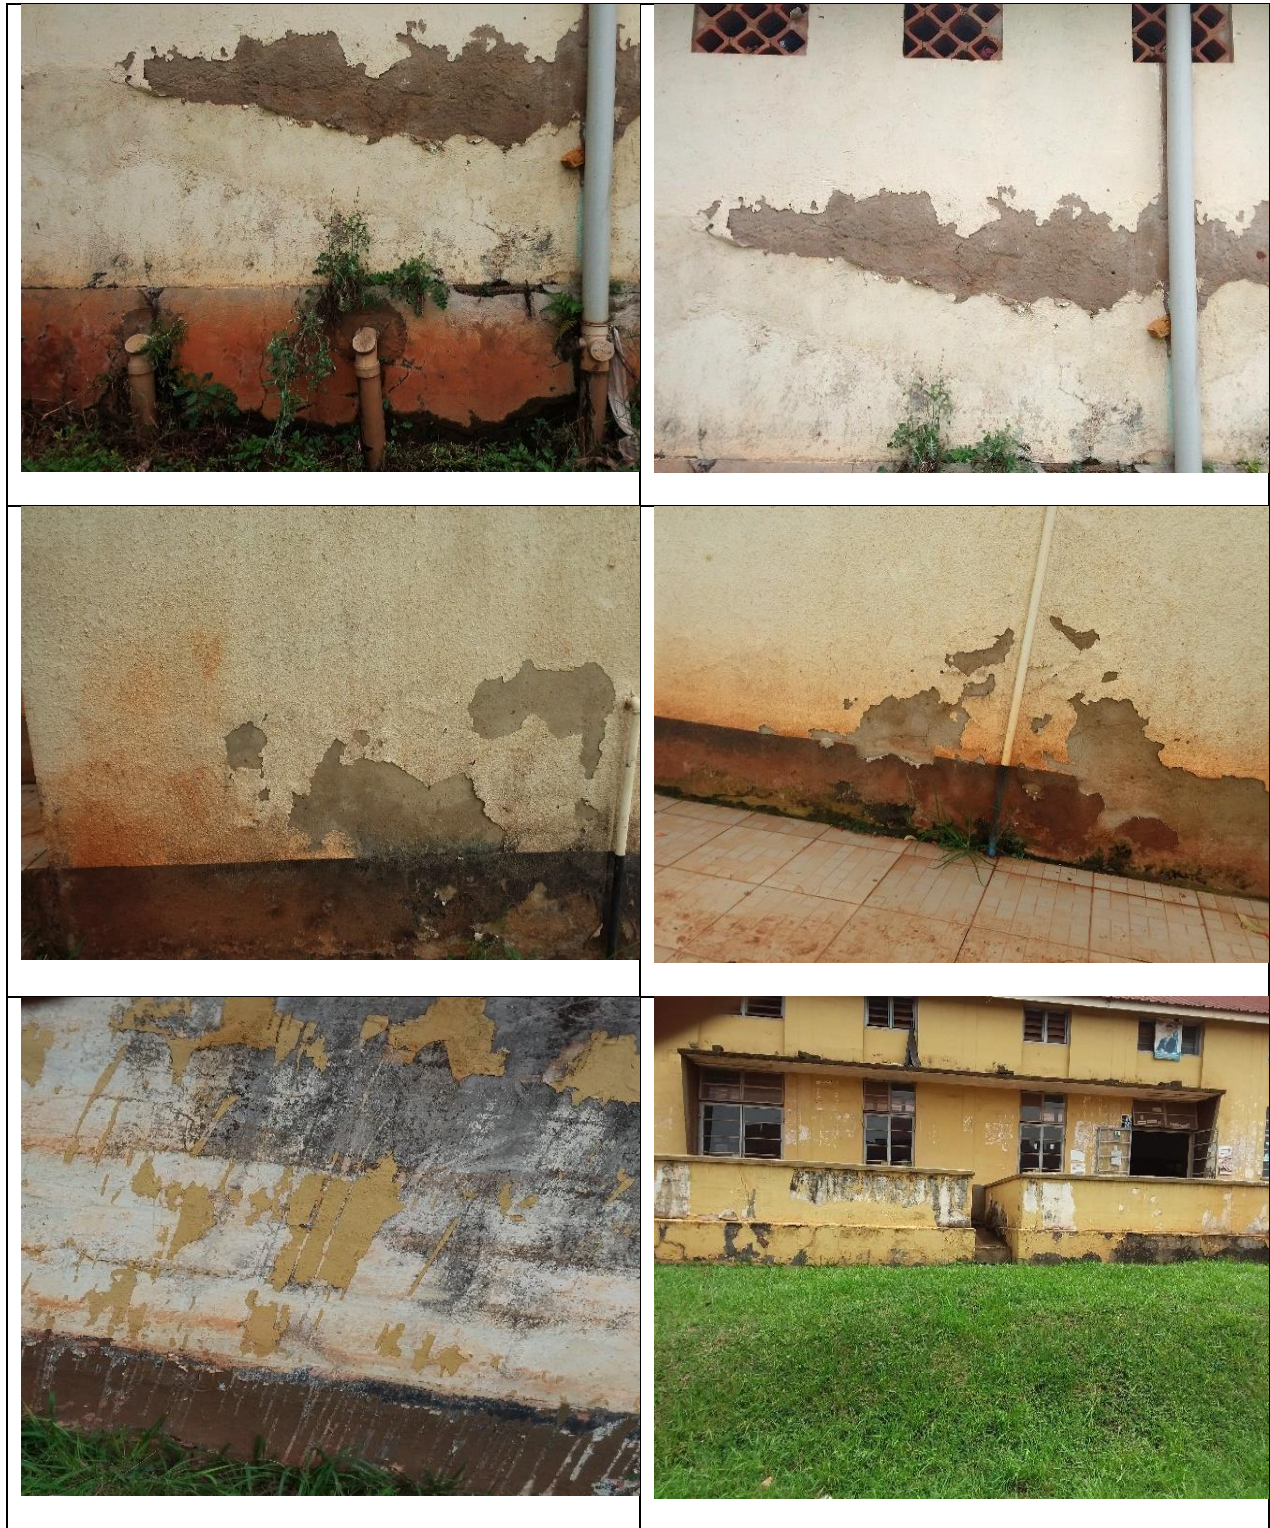
Figure A3.1: Defects in different structures in Kyambogo University - Kampala

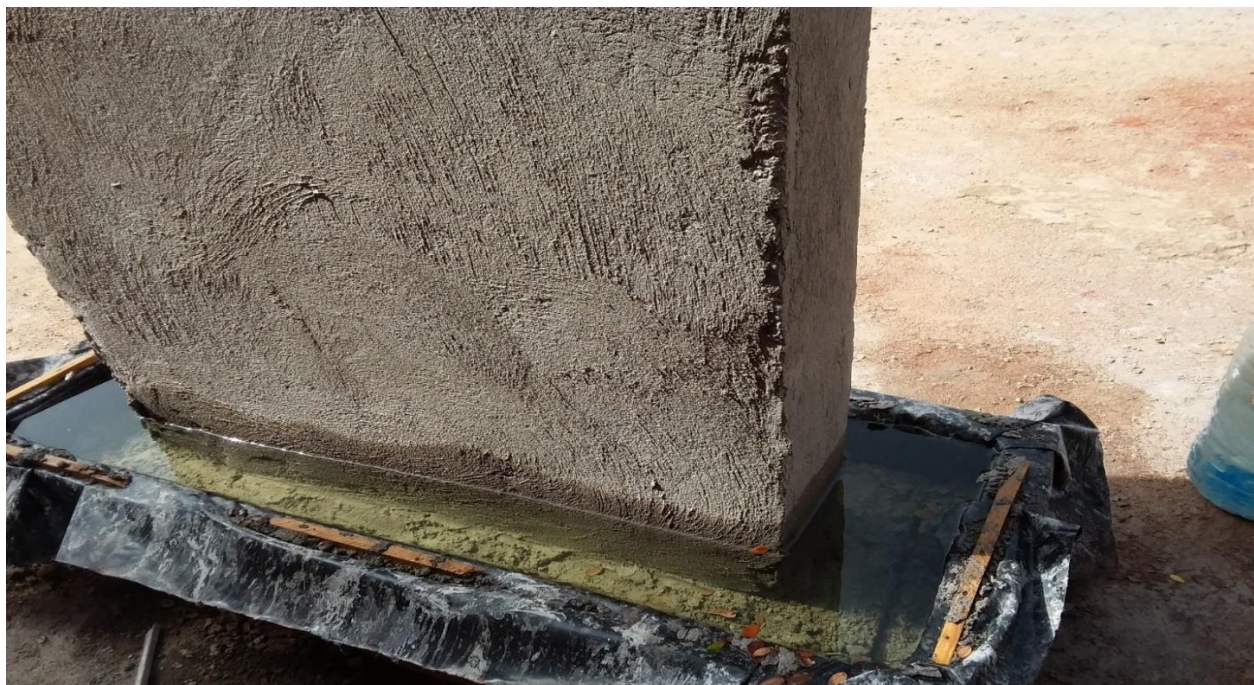
Figure A3.5: showing moisture rise through the researcher's experimental model 1, simulating a masonry wall, at Kyambogo University Soil Laboratory.

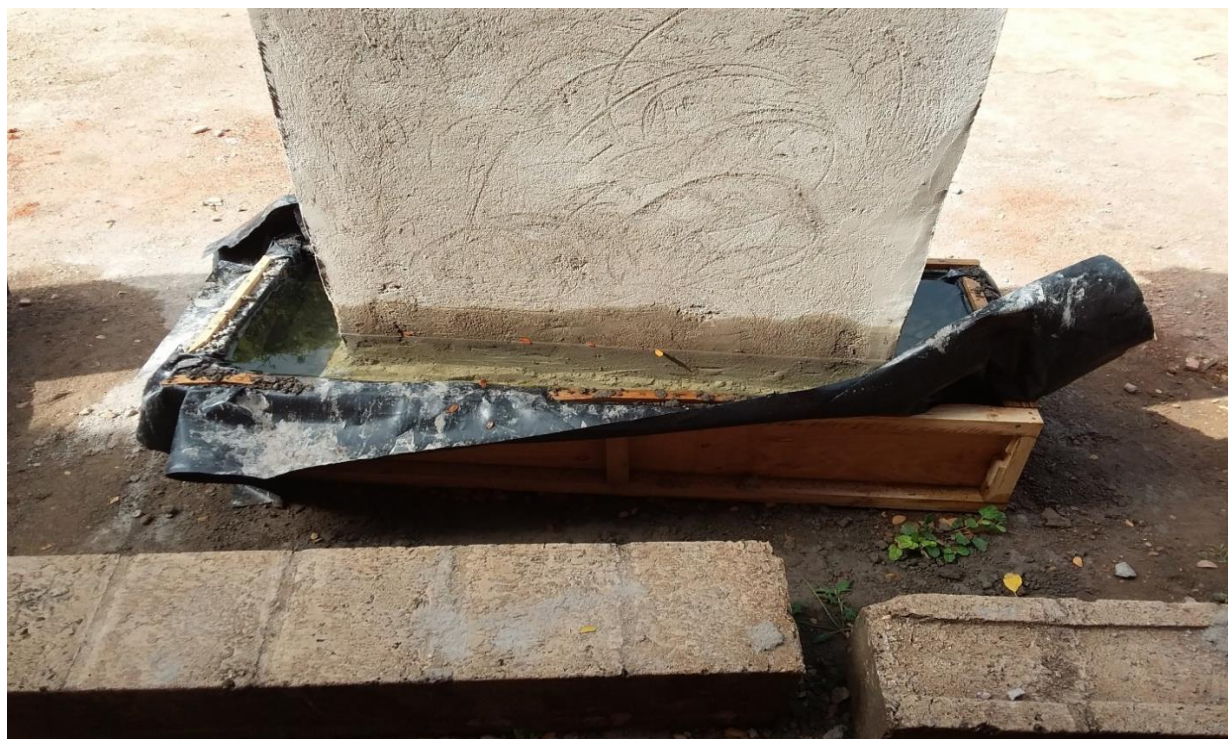
Figure A3.6: showing moisture rise through the researcher's experimental model 2 simulating a masonry wall, at Kyambogo University Soil Laboratory

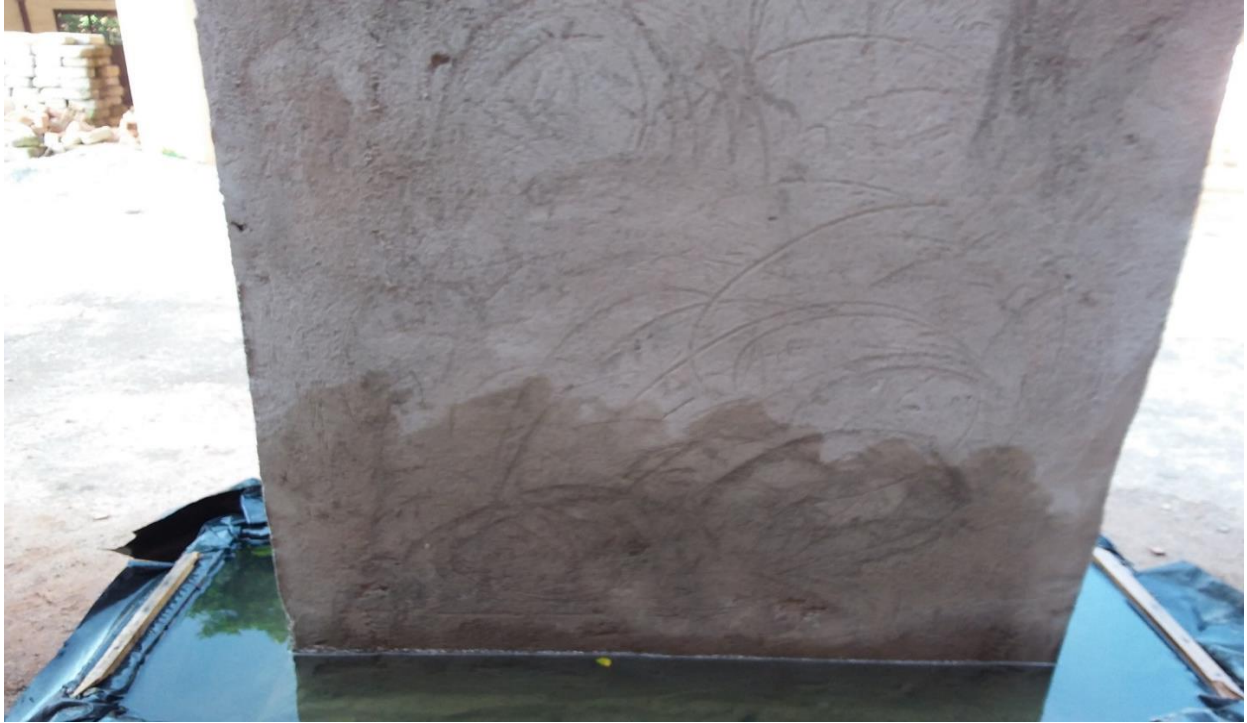
Figure A3.7: showing moisture rise through the researcher's experimental model 4 simulating a masonry wall, at Kyambogo University Soil Laboratory

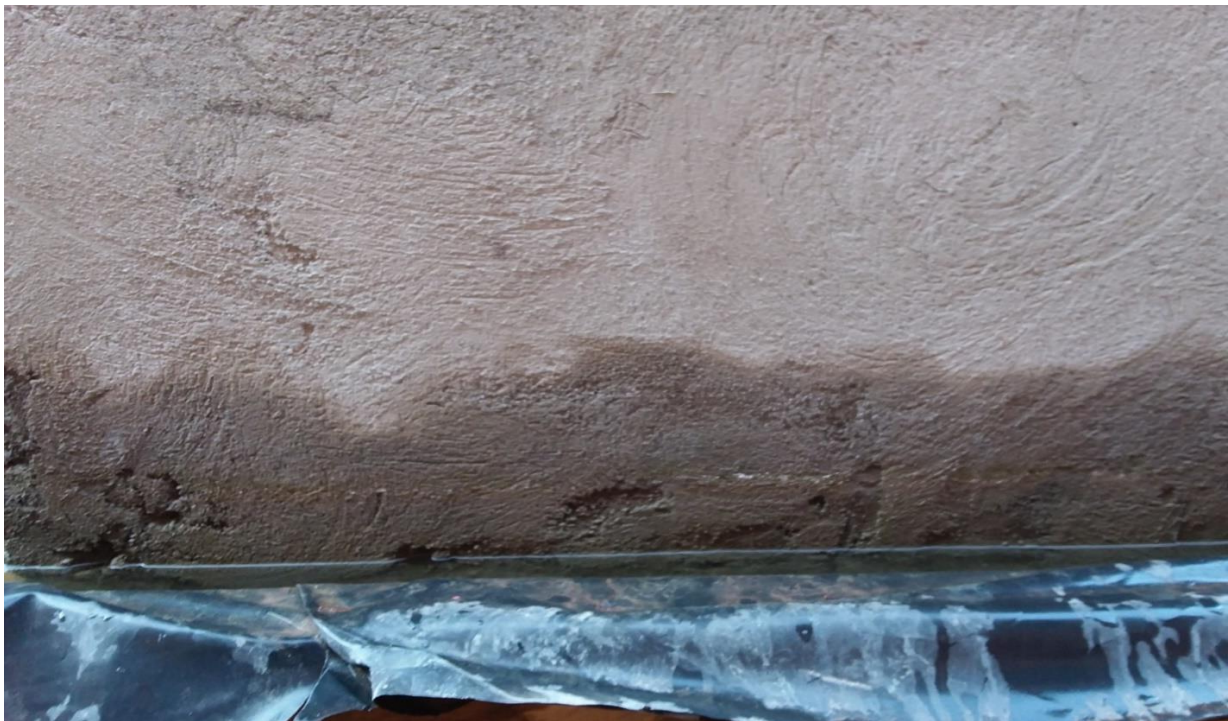
Figure A3.8: showing moisture rise through the researcher's experimental model R simulating a masonry wall, at Kyambogo University Soil Laboratory

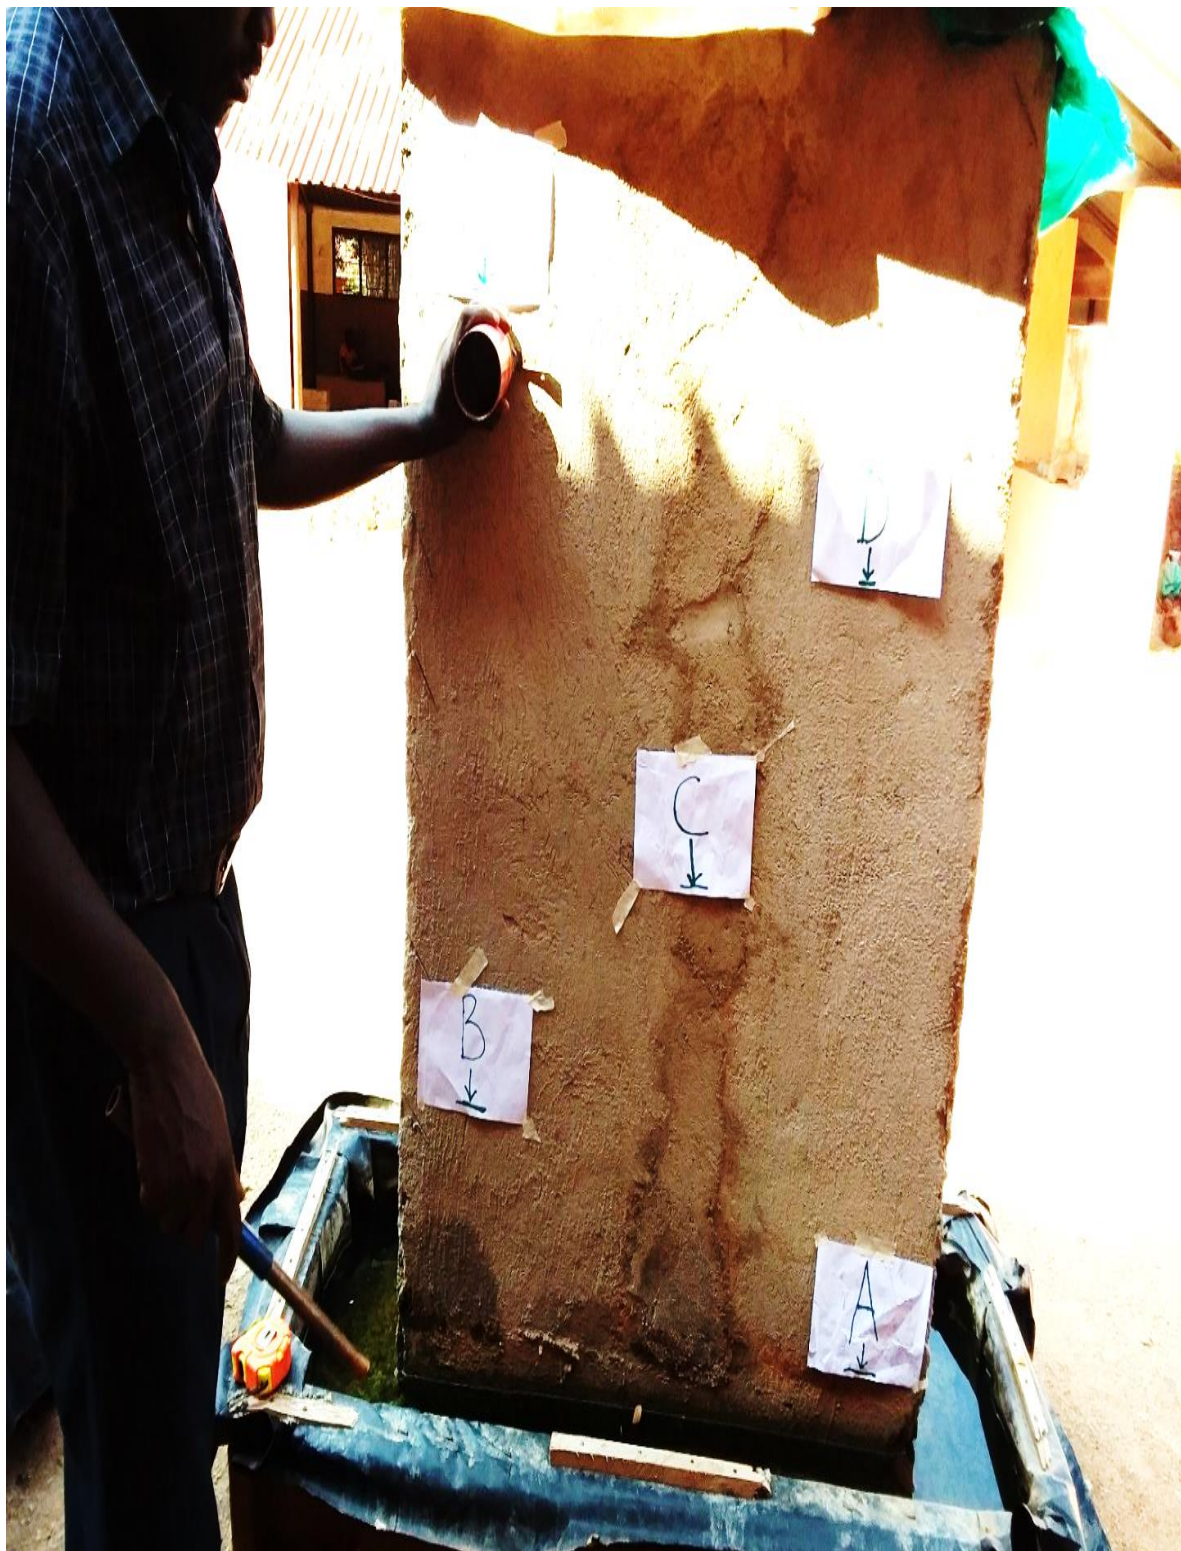
Figure A3.13: showing the researcher picking samples for m.c examination at different heights on the vertical face of one of the models, at Kyambogo University Soil Laboratory

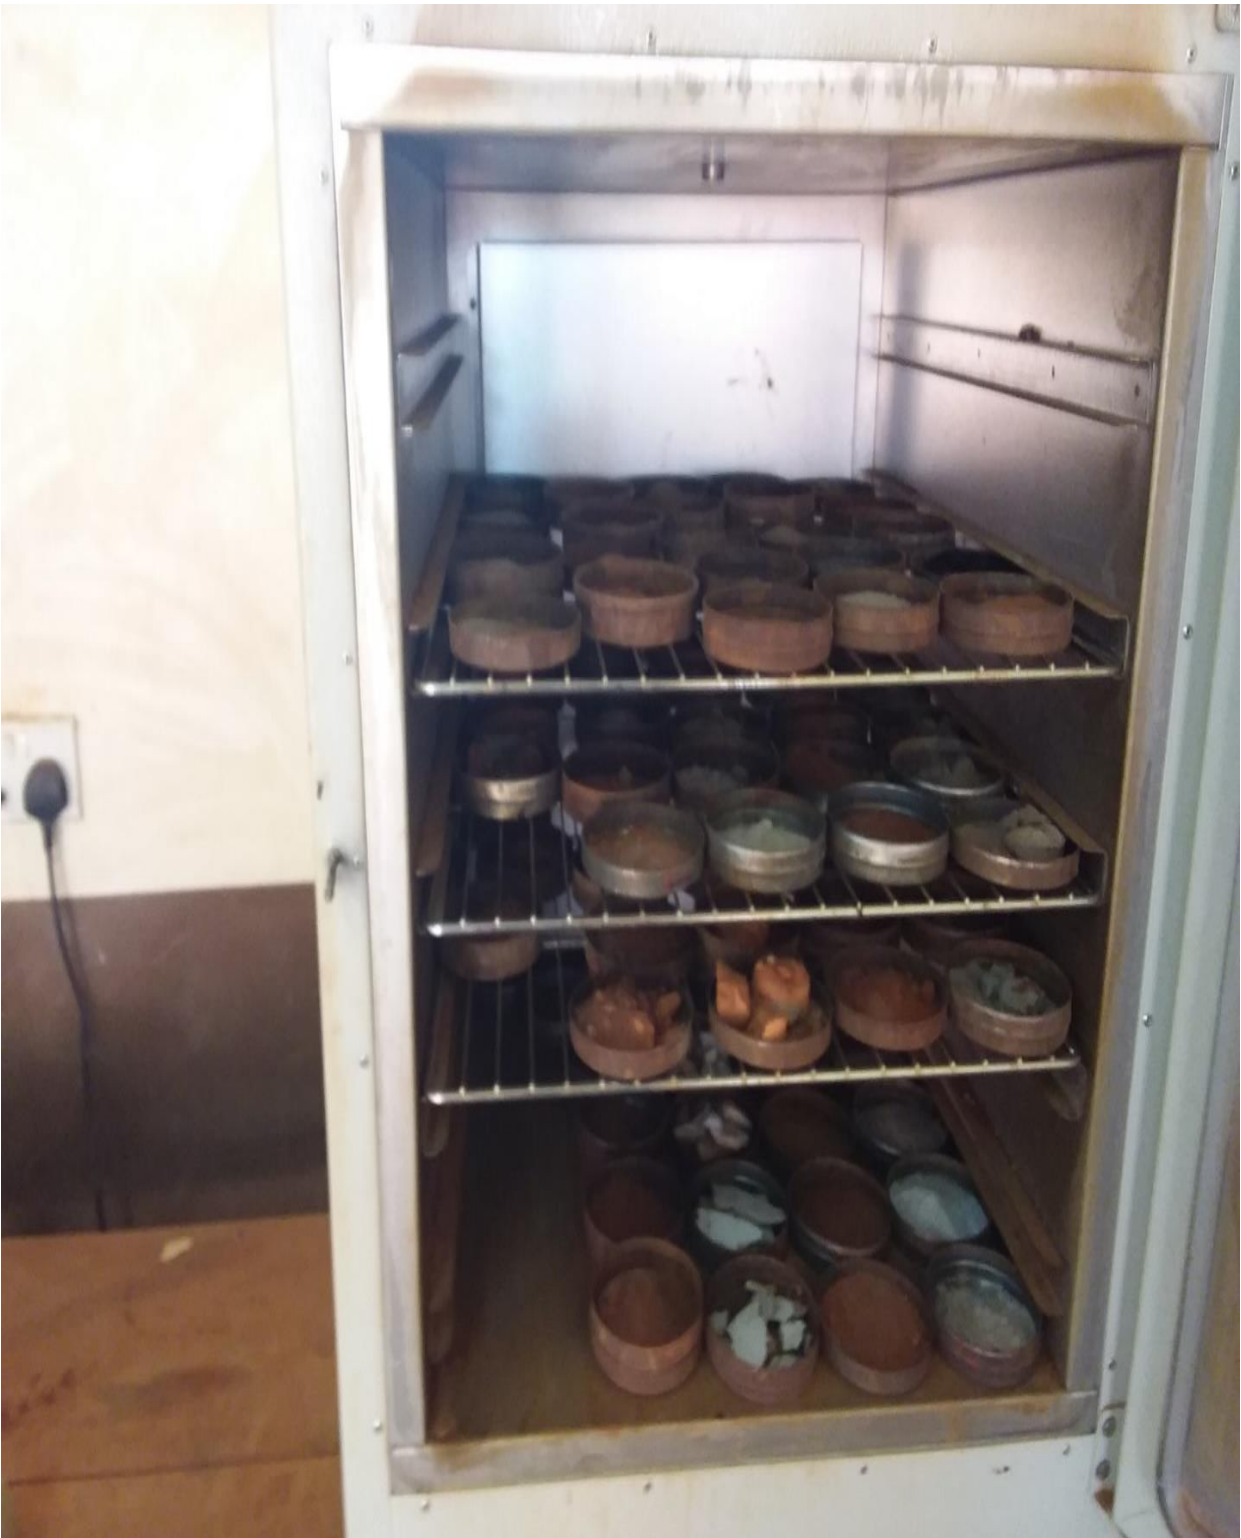
Figure A3.15: showing the researcher examining m.c on the samples in an oven, at Kyambogo University Soil Laboratory

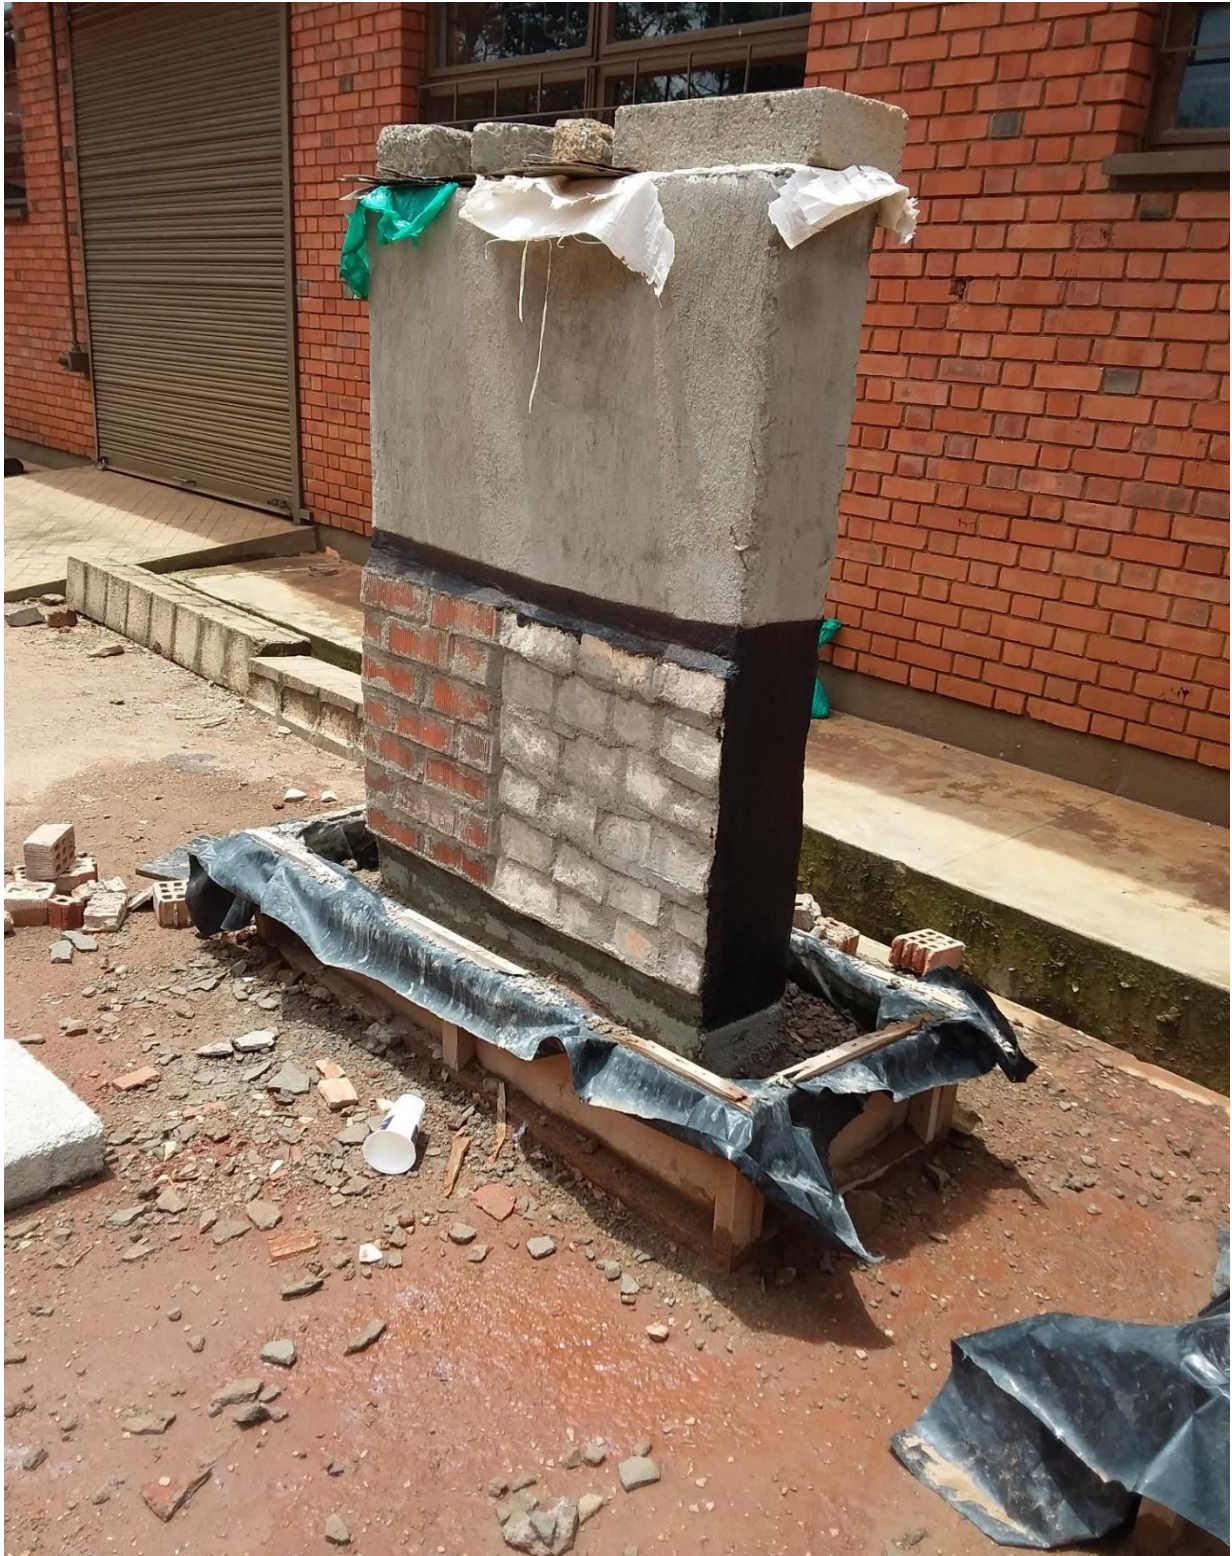
Figure A3.16: showing the different materials being examined for solution to moisture rise in masonry walls, at Kyambogo University Soil Laboratory
