**DEVELOPING A MAINTENANCE MANAGEMENT SYSTEM FOR PUBLIC
BUILDINGS IN DISTRICT LOCAL GOVERNMENTS OF UGANDA:**

A CASE OF AMURIA DISTRICT LOCAL GOVERNMENT

**A RESEARCH DISSERTATION SUBMITTED TO KYAMBOGO UNIVERSITY
GRADUATE SCHOOL IN PARTIAL FULFILMENT OF THE REQUIREMENT FOR THE
AWARD OF A DEGREE OF MASTER OF SCIENCE IN CONSTRUCTION
TECHNOLOGY AND MANAGEMENT OF KYAMBOGO UNIVERSITY**

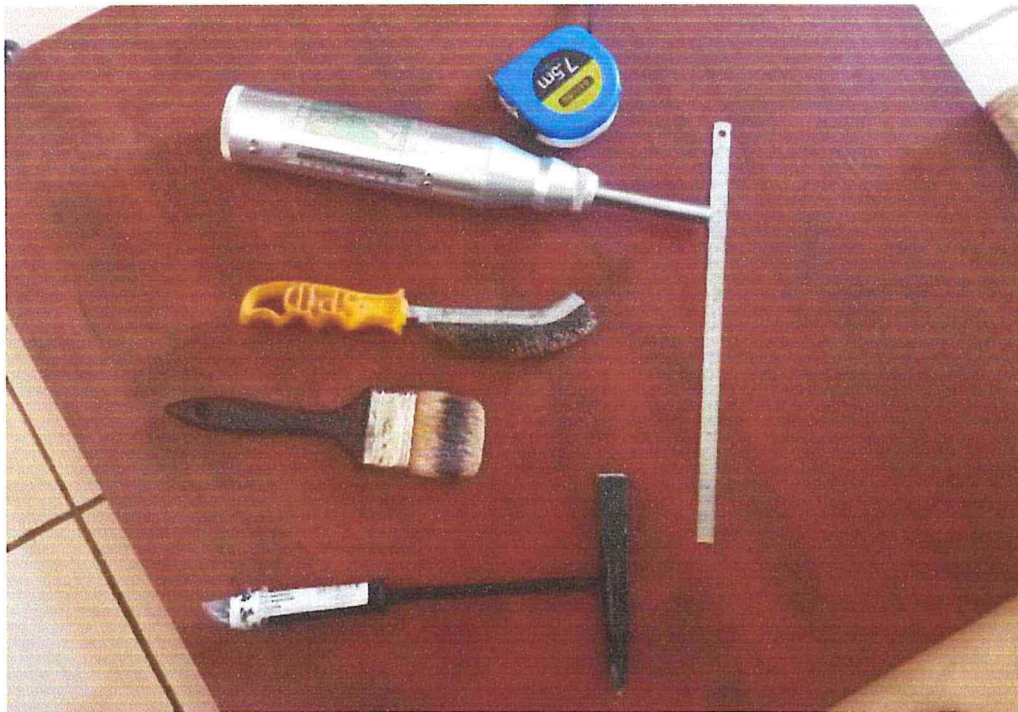
Figure. 3.2: Tools used for tests and measurement

The test for the strength was carried out with an N-type Schmidt mechanical rebound hammer. The concrete surfaces that were to be tested were first prepared by smoothing using a carborundum stone. Honeycombed regions and wet surfaced concrete were avoided and no tests were conducted on such areas. A minimum of ten shots of the hammer were taken on each chosen member, and the mean rebound reading of each member was recorded, corrected and used to obtain the average compressive strength. No chiseling or hacking was done to remove plaster, since it was a nondestructive test. For linear measurement of cracks, patches were done using a calibrated tape measure and scale rule. Figure 3.1 shows the tools that were used for physical tests and measurements during the study.

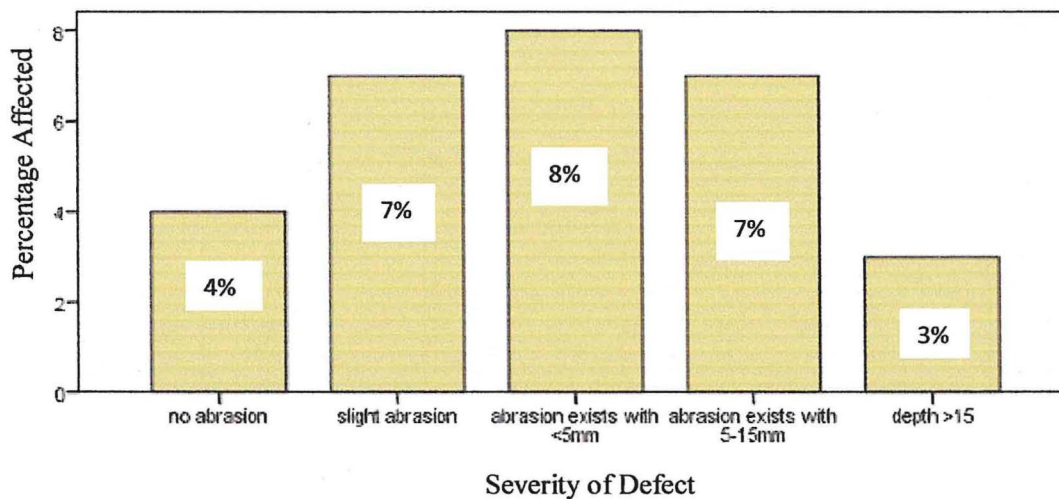
Figure 4.4: Surface deterioration

This was a defect noted to have affected the face of the component that is exposed to the environment. The researcher observed that the surface of floors and wall finishes were the most affected. The assessment conducted indicated that the floors were the components that exhibited the highest percentage of deterioration.

Figure 4.4 presents the results of the floor components that were greatly affected by the surface deterioration. The causes of defects were summarized as illustrated in Figure 4.5 showing the percentage distribution of the causes that affected the building components of the buildings that were considered during the study.

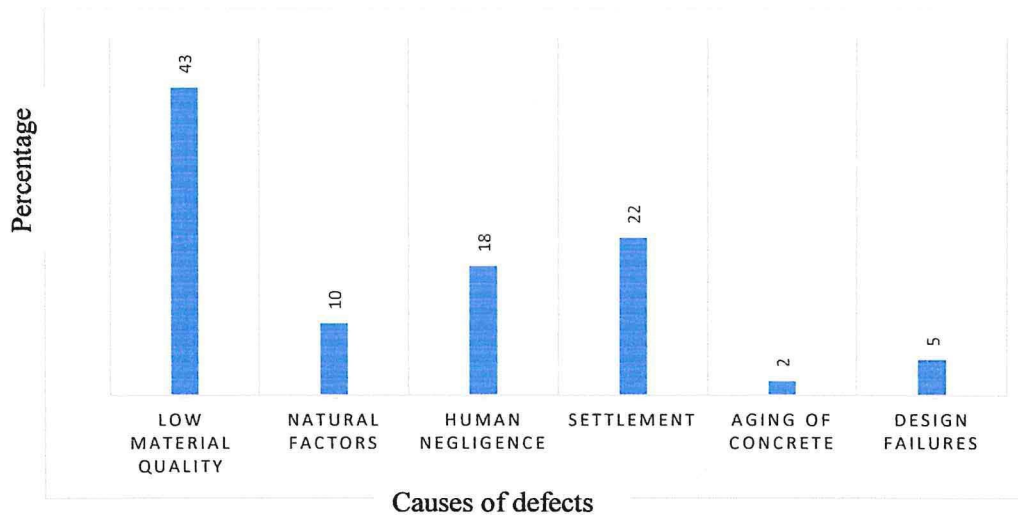
Figure 4.5: Classes of defects affecting the building Components

The severity of the defects on a building component is greatly aggravated by the causes of defects. The social, technical and environmental factors that contribute to the deterioration of building components required to be urgently addressed to as to improve on the life span of the components (Chan, 2014). In this way the buildings would be well attended to and the whole life cycle costs involved in the maintenance management of building components would be greatly reduced and could be allocated to other development priorities. Besides the costs, the occupants have no risk exposure to the health and safety conditions of the buildings.

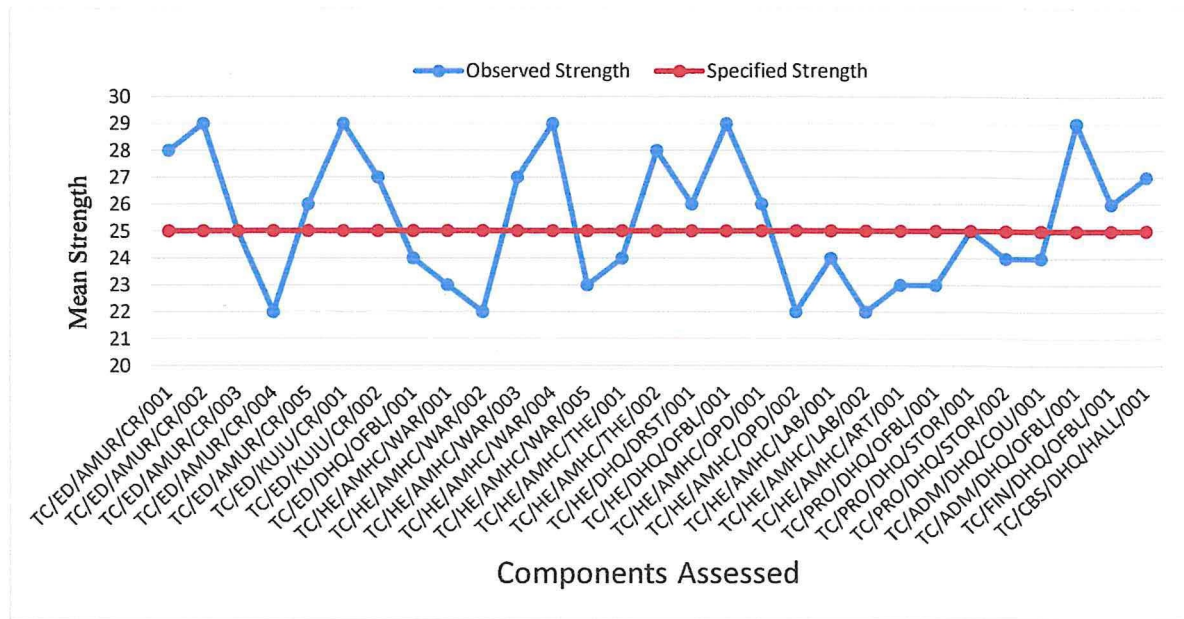
Figure 4.8: Average strength of beam components

The beams whose strengths were assessed were of reinforced concrete. The assessment of the strength of beams was conducted to establish the compressive strength. These were observed to be in the range of from the results of the rebound Schmidt hammer that had a range from 22MPa to 29MPa. Figure 4.8 presents results of the average beam strength for the buildings assessed were compared with the specified concrete strength of C25 for all the contract documents that were reviewed.

The results indicated that 55.2% of the components had the minimum specified strength of 25MPa and 44.8% had less than the specified strength. This implied that the components with less strength than the specified required more and regular attention to rectify any defects noticed as a measure to maintain the building component.

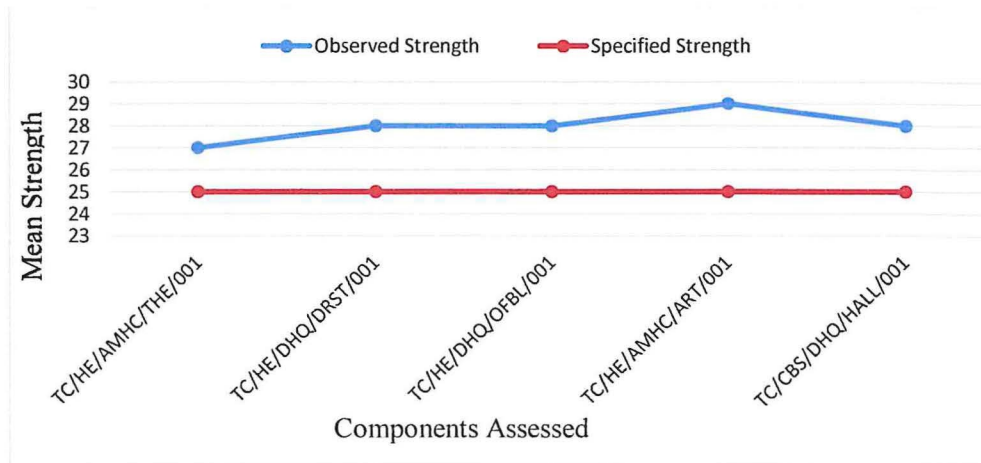
Figure 4.9: Average strength of Column components

The results indicated that 100% of the concrete columns assessed had strength above the minimum specified strength of 25MPa as seen in Figure 4.9. These results signified that none of the components had the requirement for immediate maintenance intervention. As observed from the results of the rebound Schmidt hammer, the strengths had a range from 27MPa to 29MPa. The

results indicated that the quality of concrete used was good according to Table B – 5 in Appendix B.

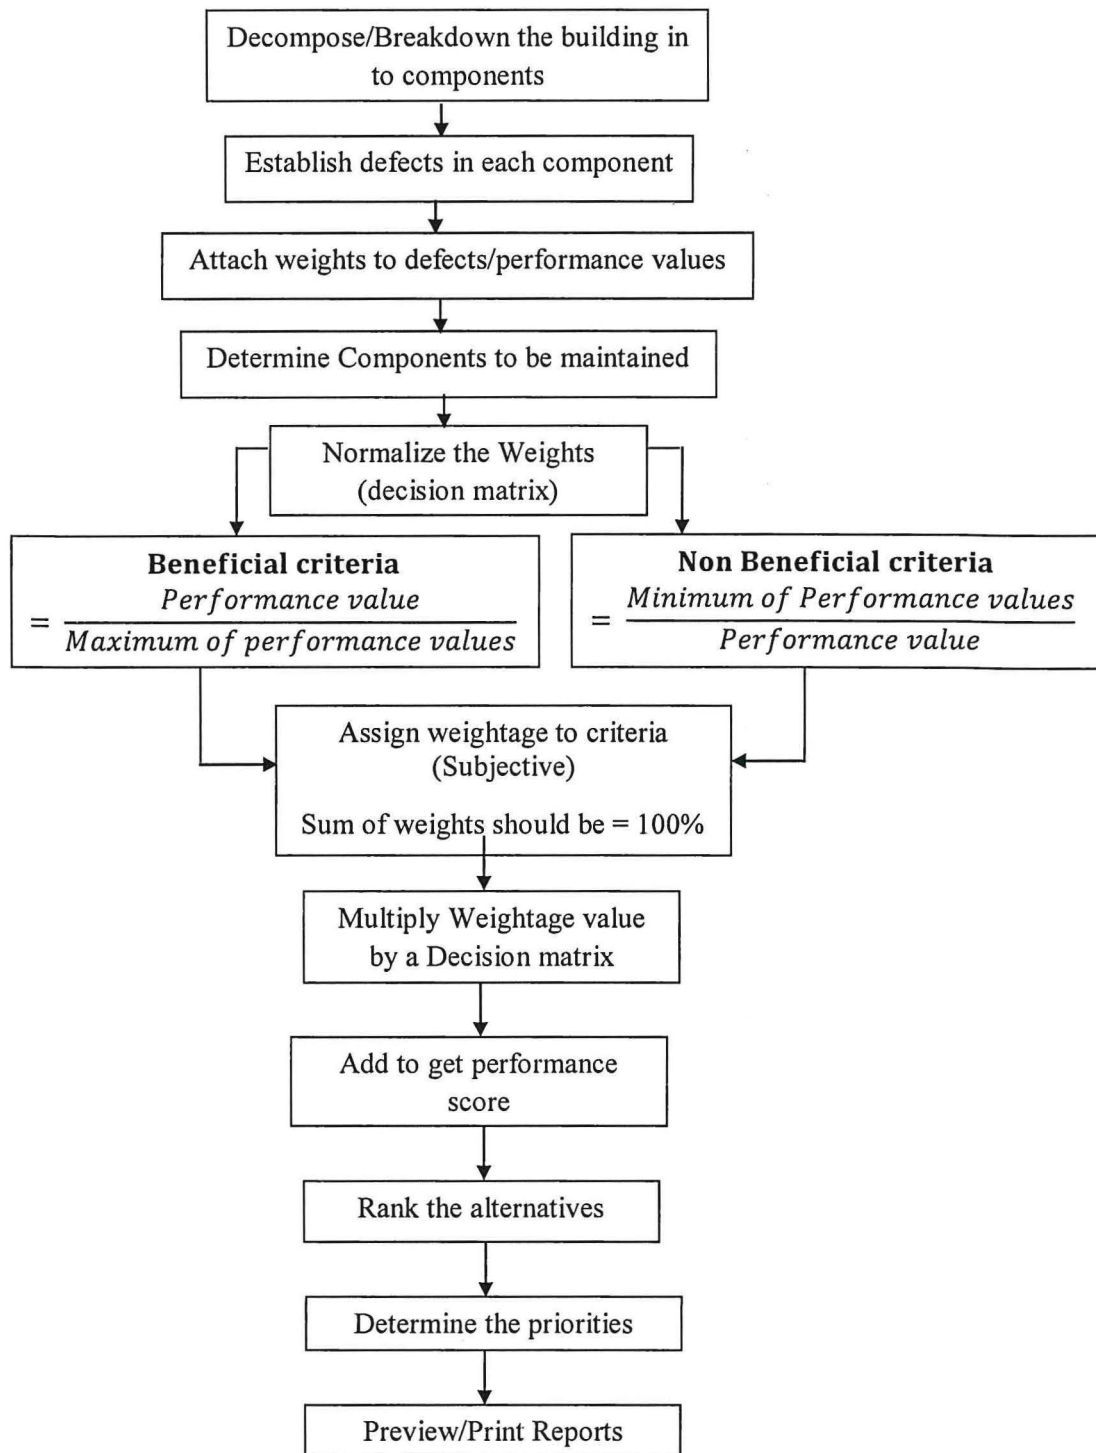
Fig. 4.10: Developed Maintenance Management System

This involves breaking down the building into components or elements. The common elements of a building that were considered include: Roof, Ceiling, Walls, Floors, Beams, and Columns. Since different building elements were affected by a number of defects, they cannot be ordinarily added up together to give the final

score that is considered during ranking of elements. These elements are considered as the “criteria” in the decision matrix computations.

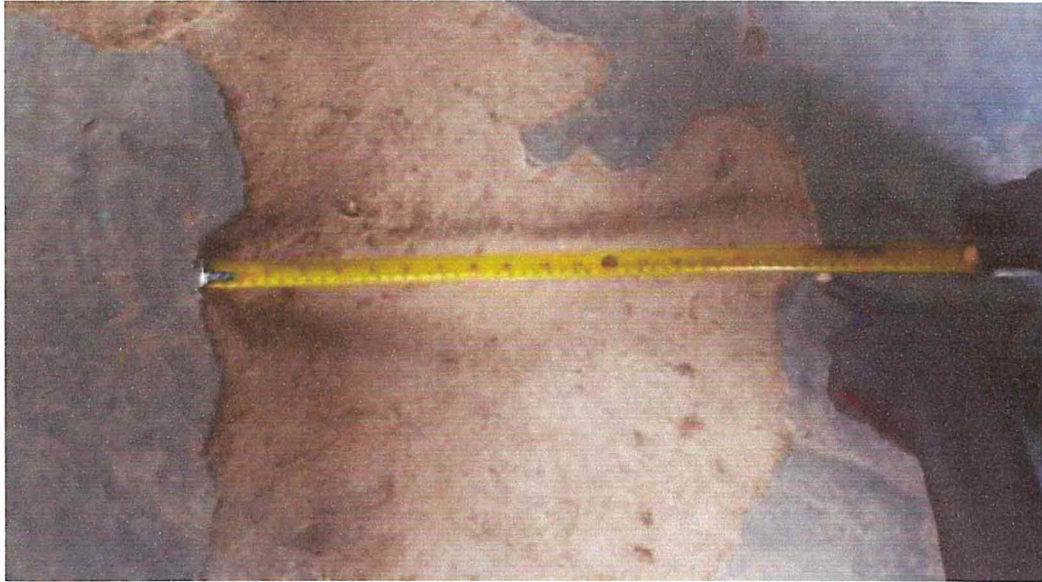
Figure 7.1. Patches on the Council Chambers Cement Sand Screed Floor Finish

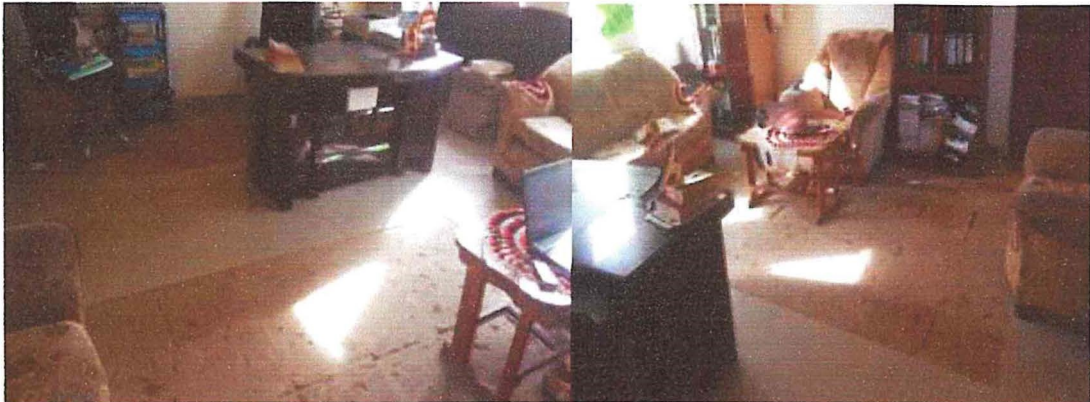
Figure 7.2. Patches of missing Floor tiles at the District Water Office

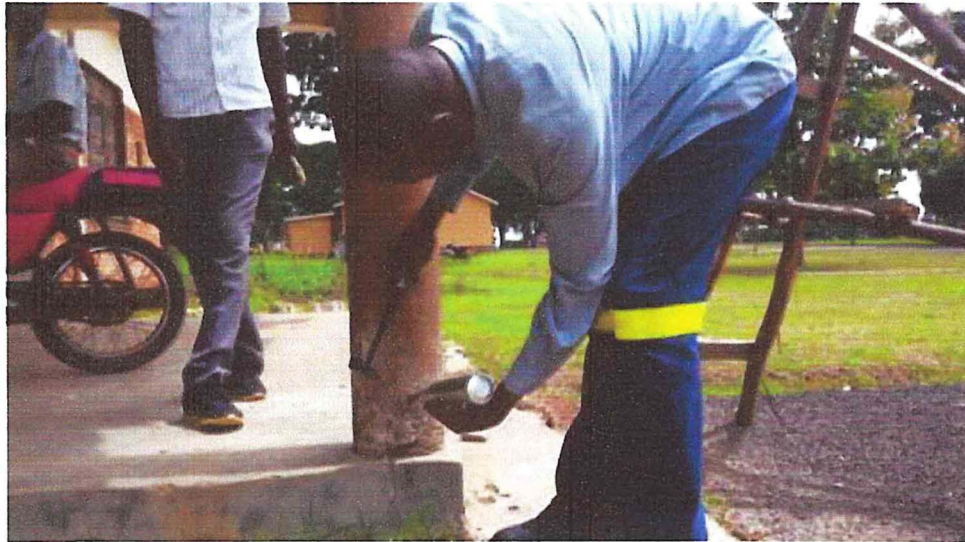
Figure 7.3: Cracks at the bottom of the Column at the District Health Drug Store.

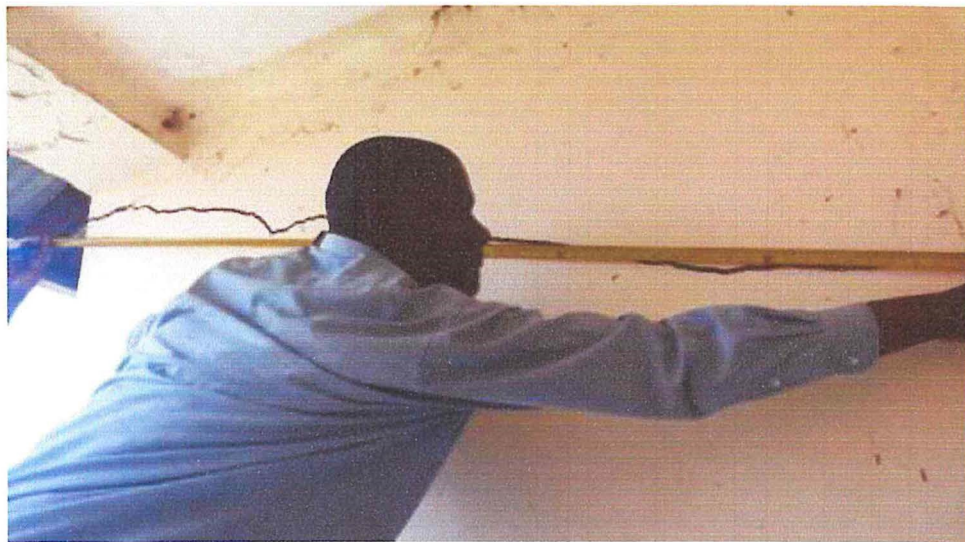
Figure 7.4: Crack along the partition wall of a theatre at Amuria H/C IV.

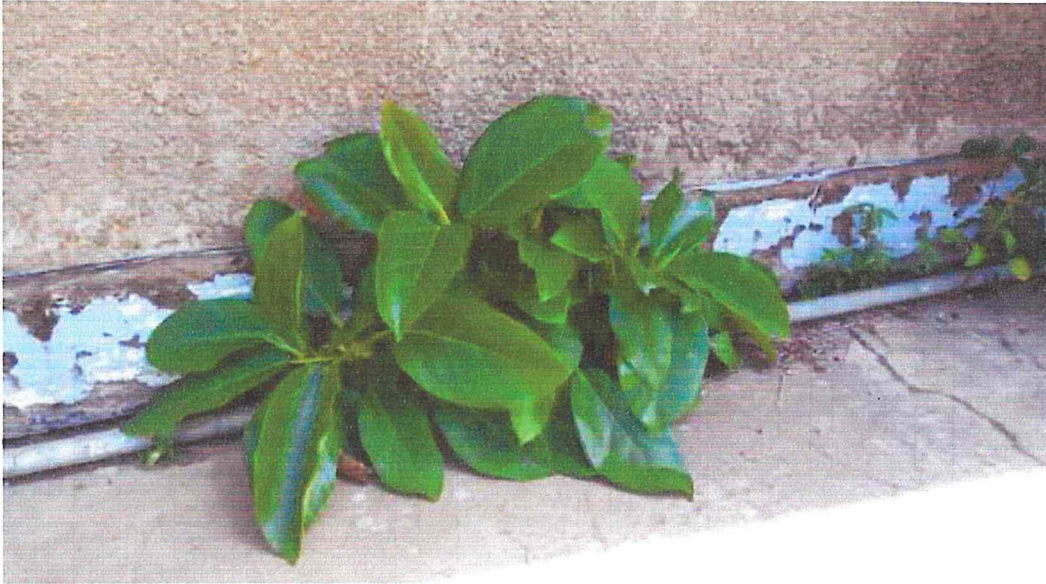
Figure 7.5: Plant growth at the External wall of the Operating Theatre at Amuria H/C IV.

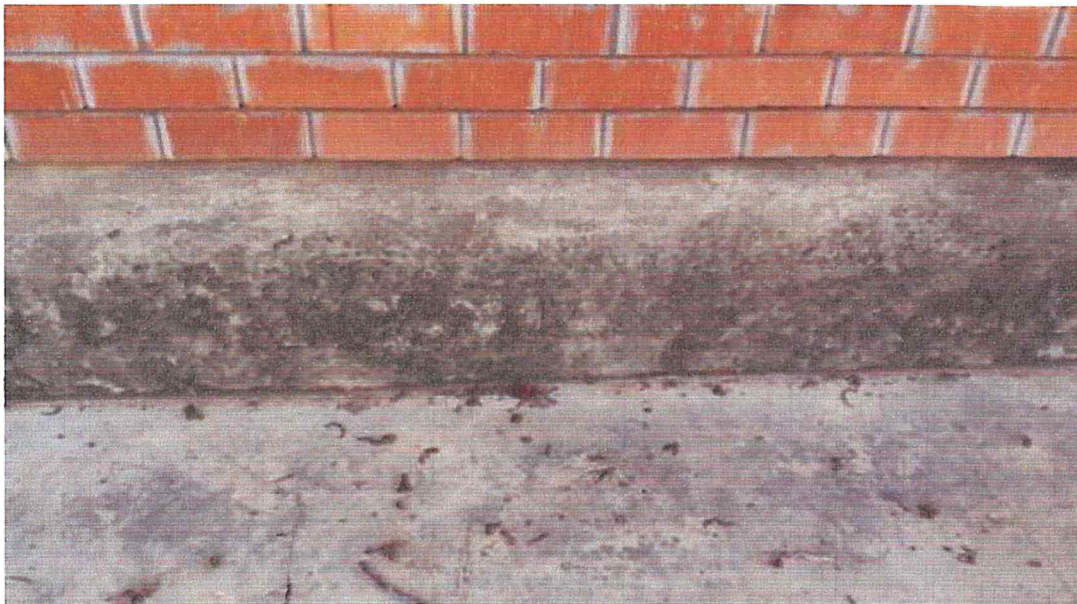
Figure 7.8: Dampness at the External wall of the District Health Drug Store

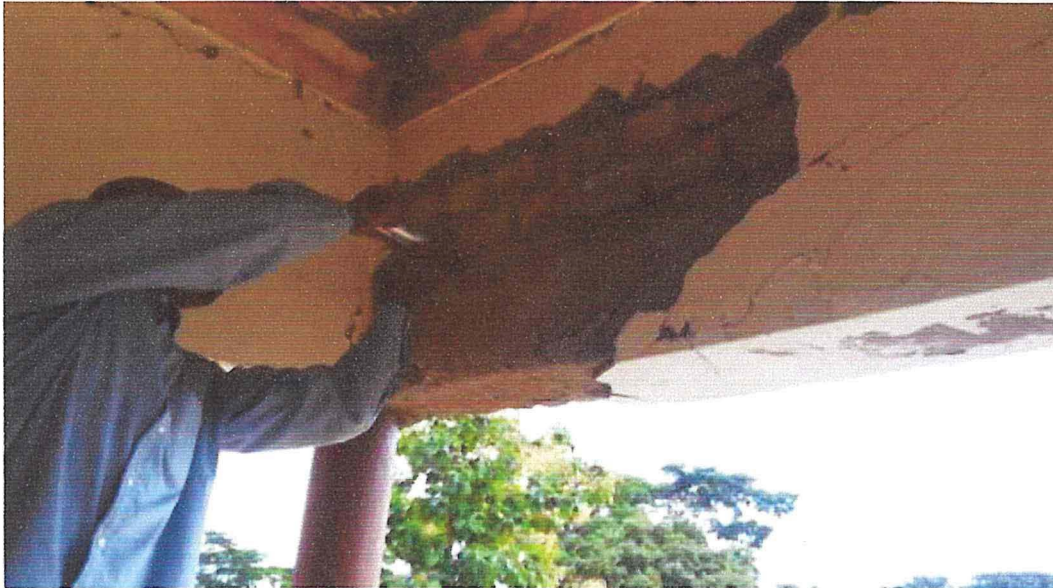
Figure 7.9: Cracked beam at the District Drug Store.

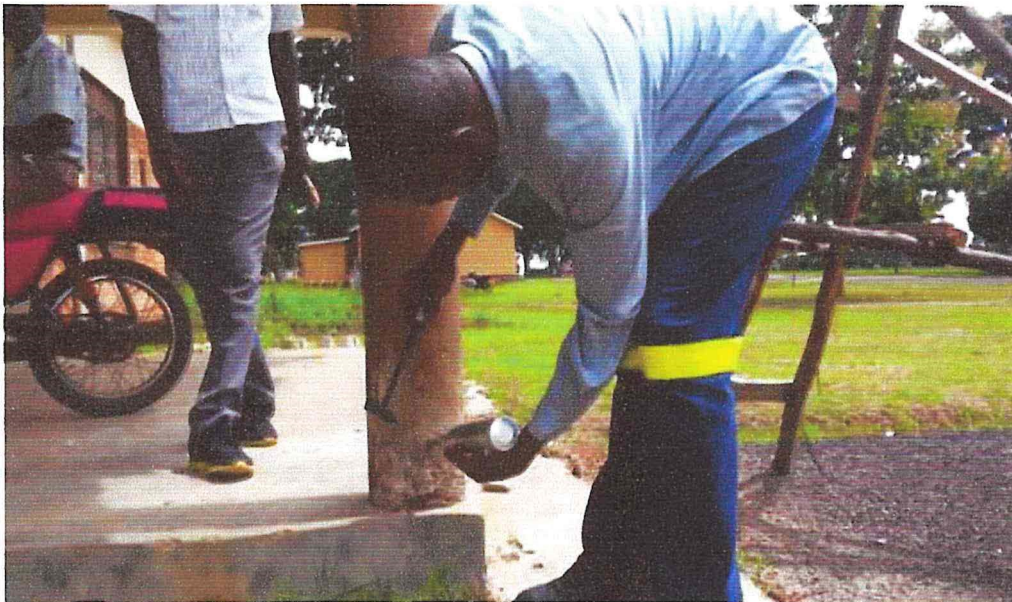
Figure 7.10: Cracks at the bottom of the Column at the District Health Drug Store.

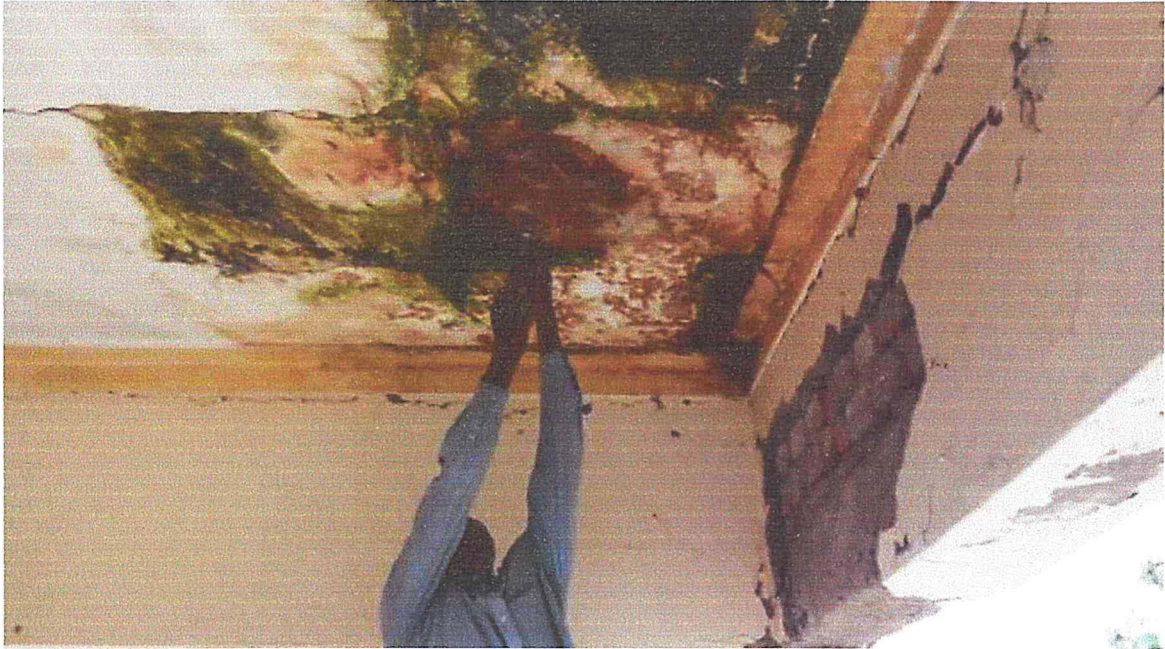
Figure 7.11: Algal growth at ceiling of Amuria District Health Drug Store

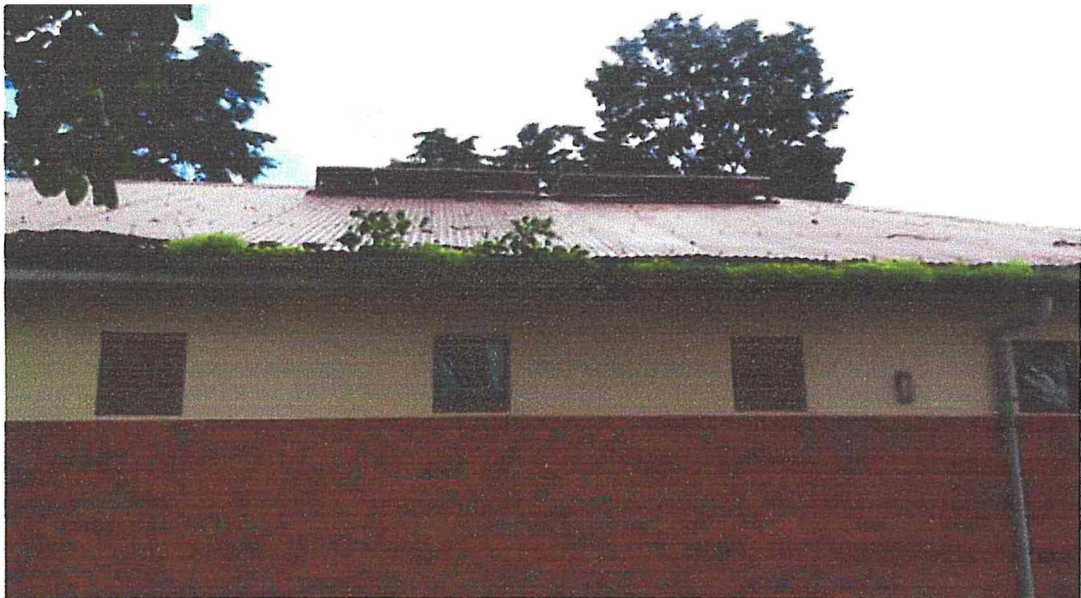
Figure 7.12: Plant growth along the gutters at Amuria District Health Drug Store

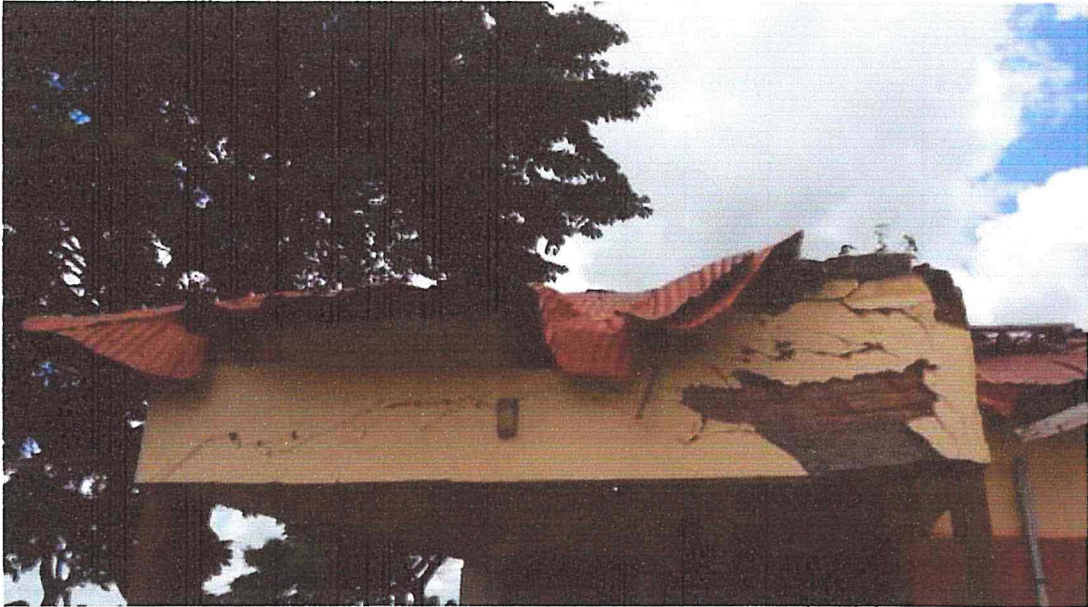
Figure 7.13: Damaged roof structure of Amuria District Health Drug Store
